CLARION HOTEL
TWIN LAKES, CO
HISTORIC STRUCTURE ASSESSMENT

PREPARED FOR:
FRIENDS OF TWIN LAKES
SHF 14-HA-008
FEBRUARY 5, 2015
DELIVERABLE #5

SHF 14-HA-008
FEBRUARY 5, 2015
5LK.41

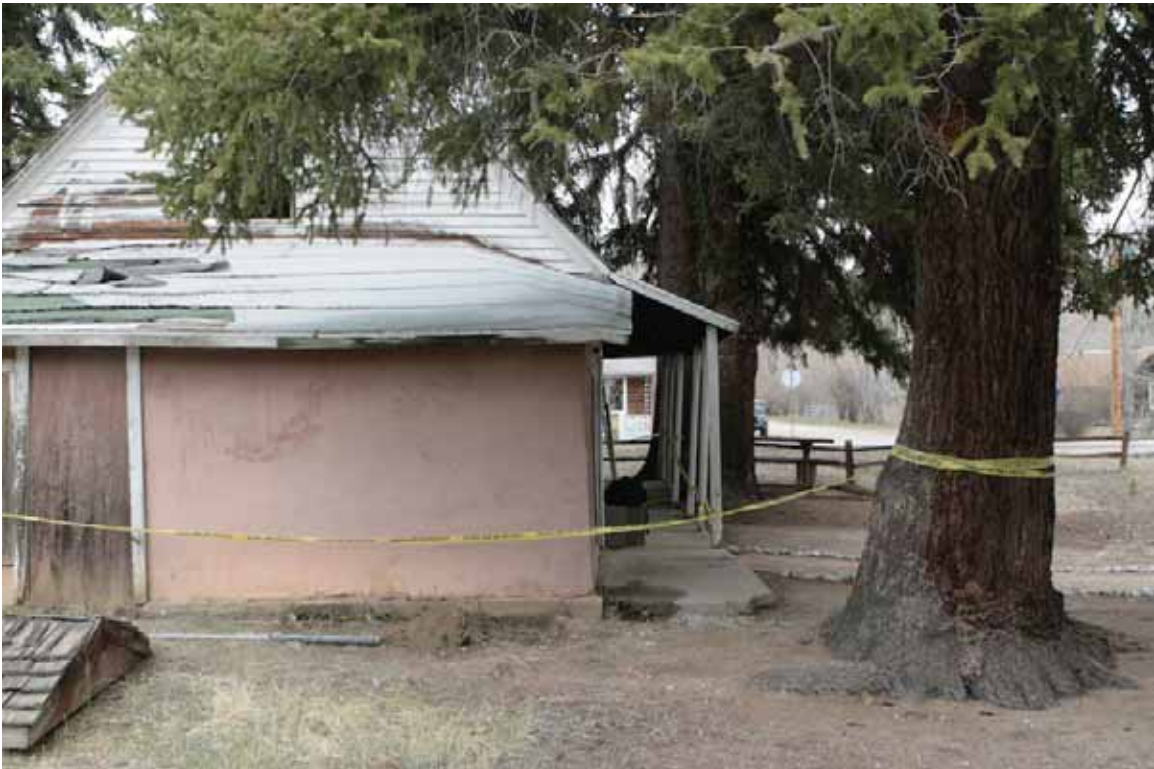
Photo 3.1-3. Site along south and east sides

The exterior grade around the lean-to is in poor condition. It does not appear to slope away from building footprint. (Photo 3.1-3) Because the grade has been raised, it is in contact with the stucco and adobe exterior walls and makes them susceptible to moisture infiltration. Exterior grade along the east and west sides of the main building has slight positive drainage. (Photos 3.1-5, 3.1-3) The north side is dominated by the large spruce trees, whose roots cause the grade to slope towards the building along that side. This condition has also caused uplift in the north porch columns and porch roof. (Photo 3.1-4)

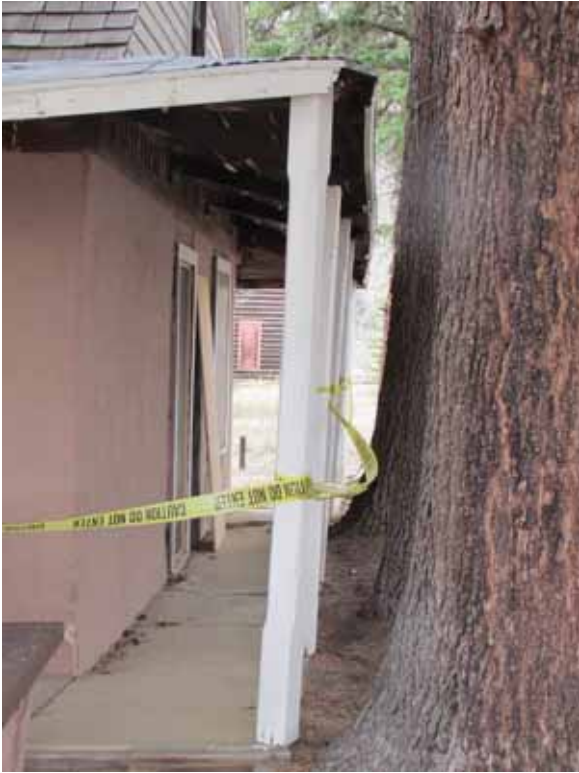
Photo 3.1-4. Looking west along north porch showing concrete porch slab, porch roof and spruce trees

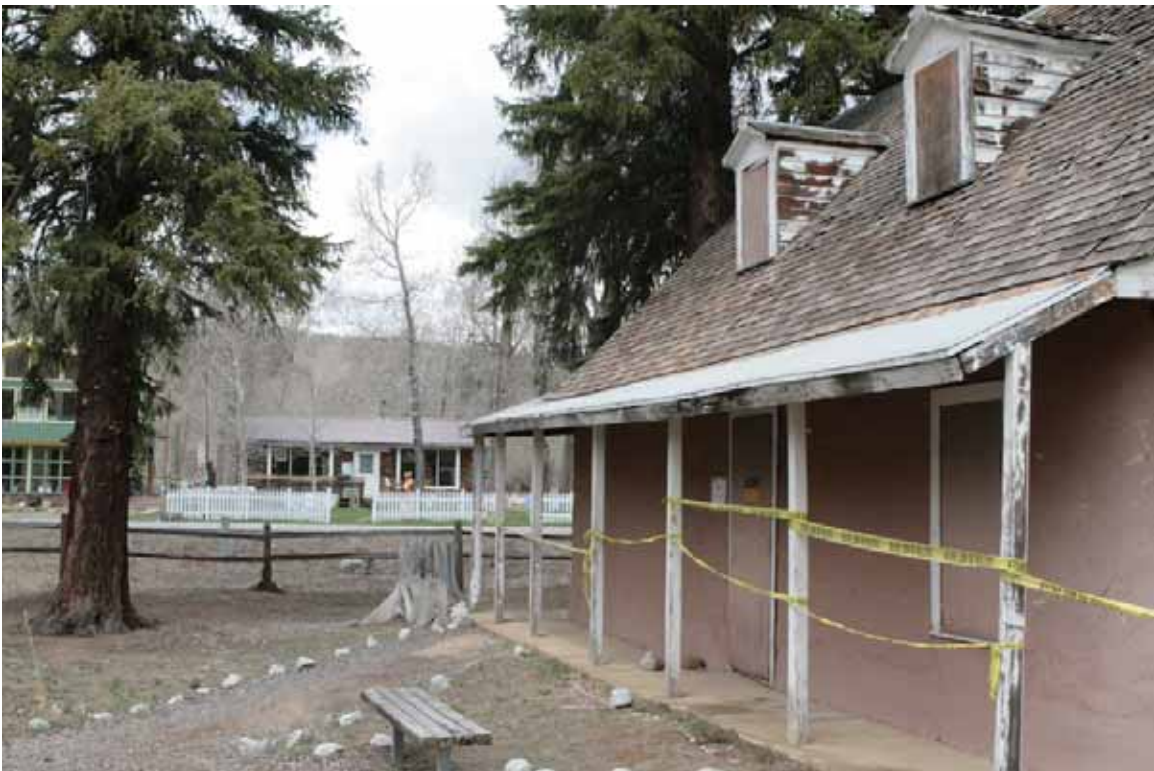
Photo 3.1-5. Looking north along west porch showing concrete porch slab, porch roof, footpath with stone edging

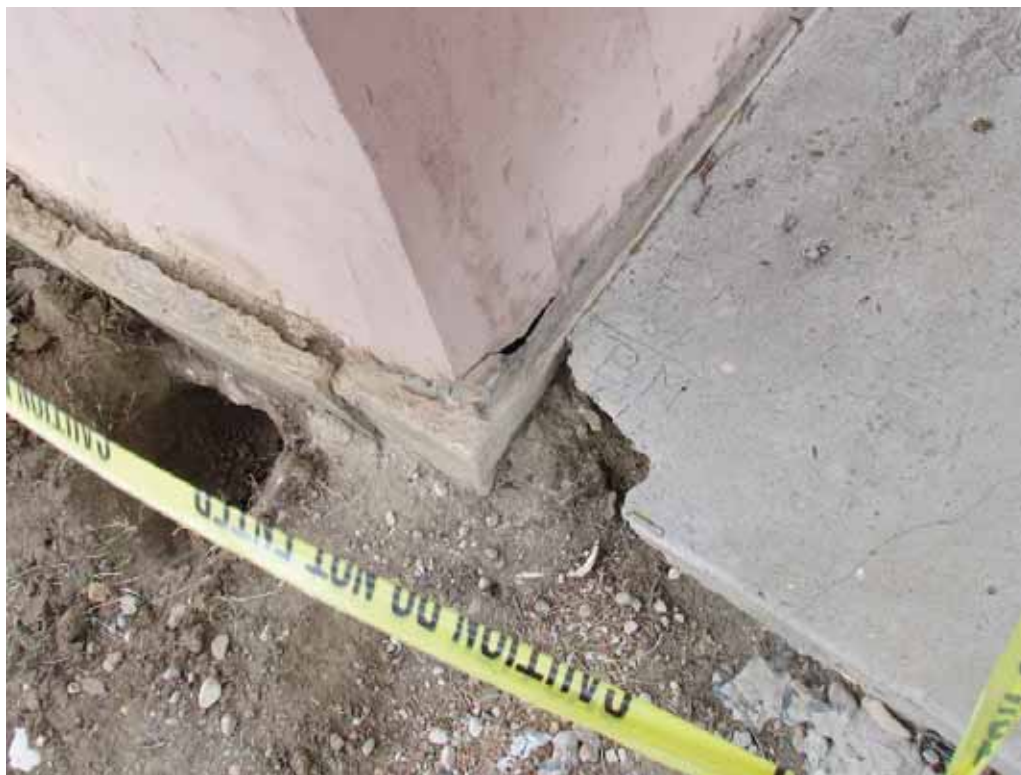
Photo 3.2-1: Exterior sidewalk damage and burrow hole at southeast corner

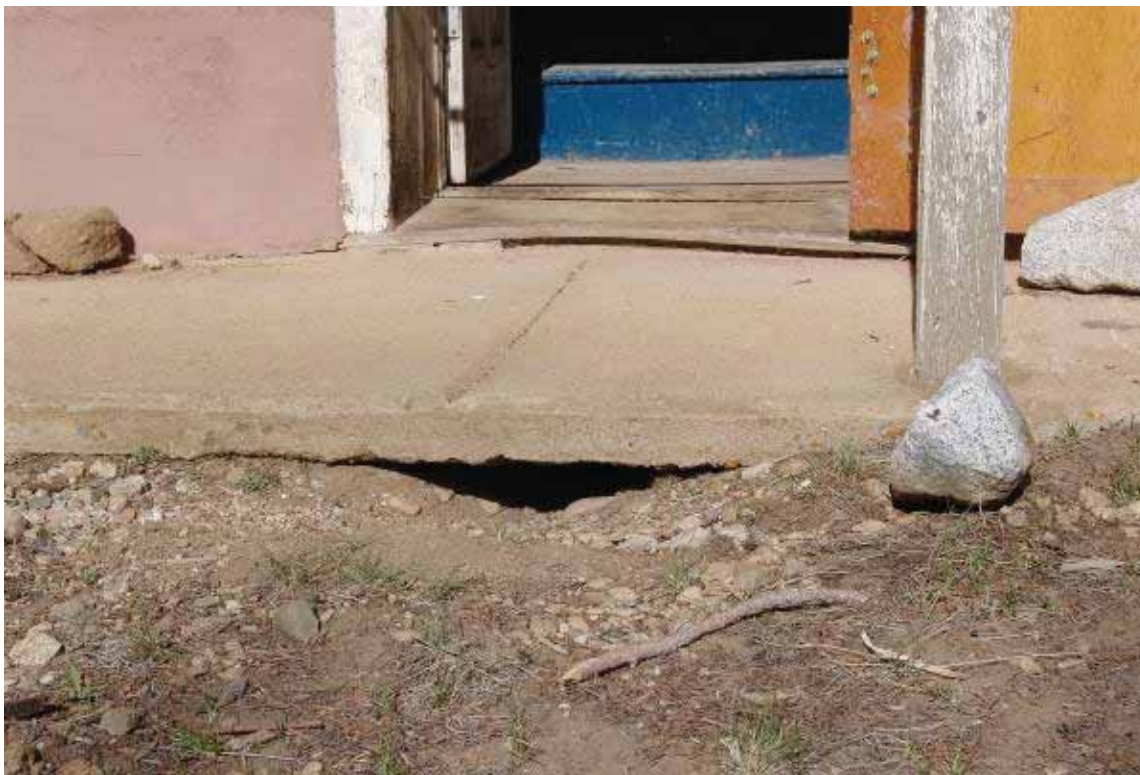
Photo 3.2-2: Burrow hole beneath exterior concrete sidewalk, west side

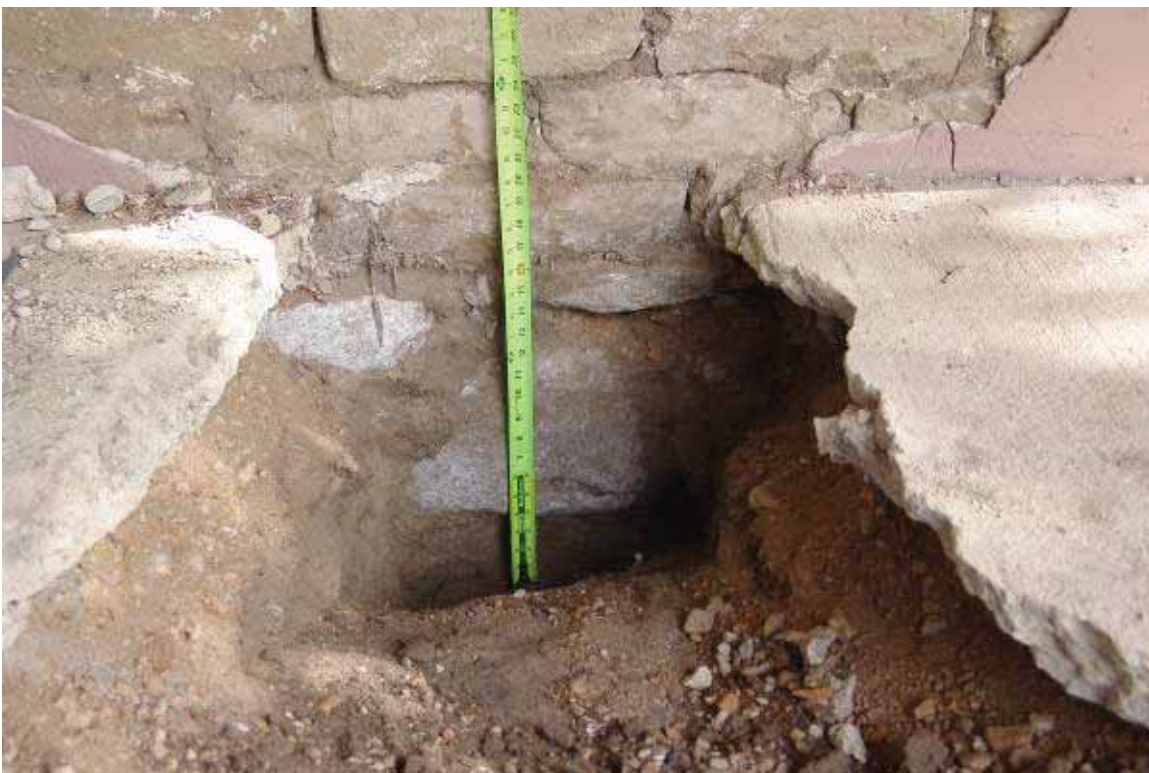
Photo 3.2-2: Depth of foundation as measured from exterior exploratory excavation along north elevation

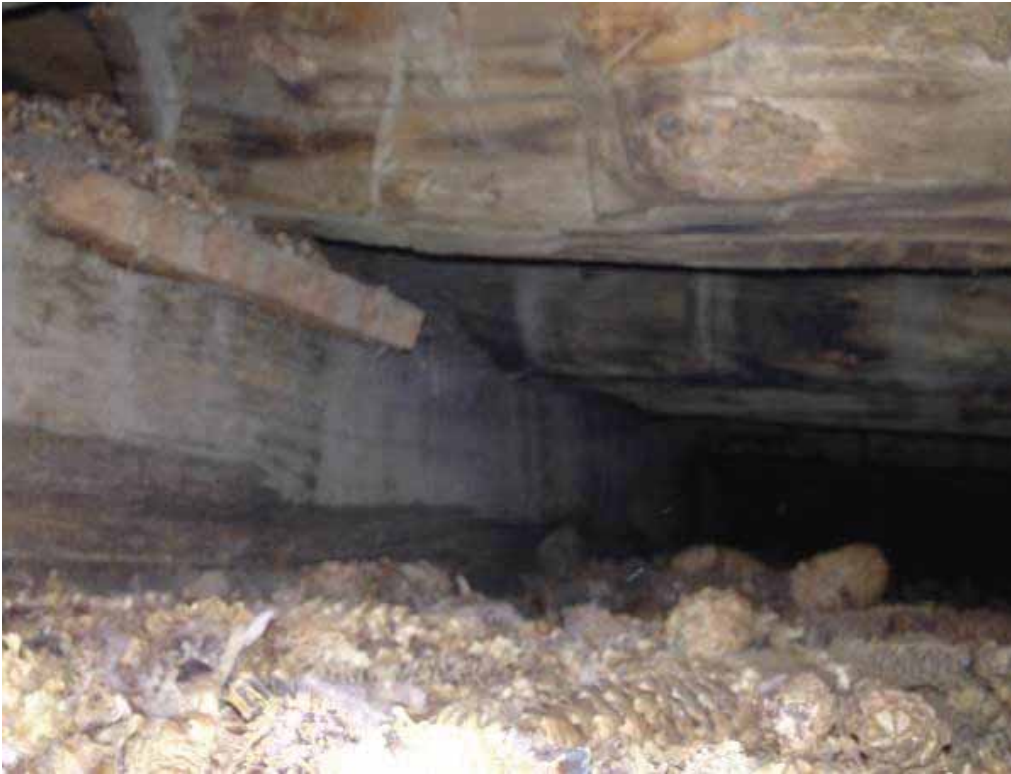
Photo 3.2-3: Log sill/foundation dividing north and south first floor framing bays

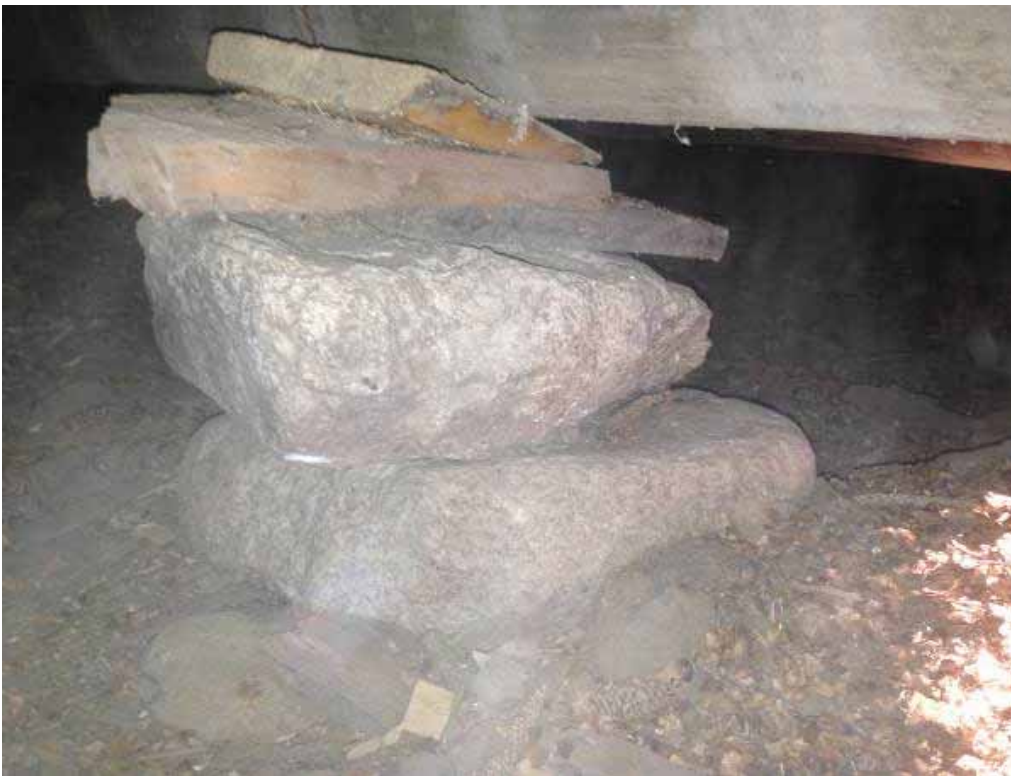
Photo 3.2-4: Singular stacked stone support at midspan of a log joist in the south bay

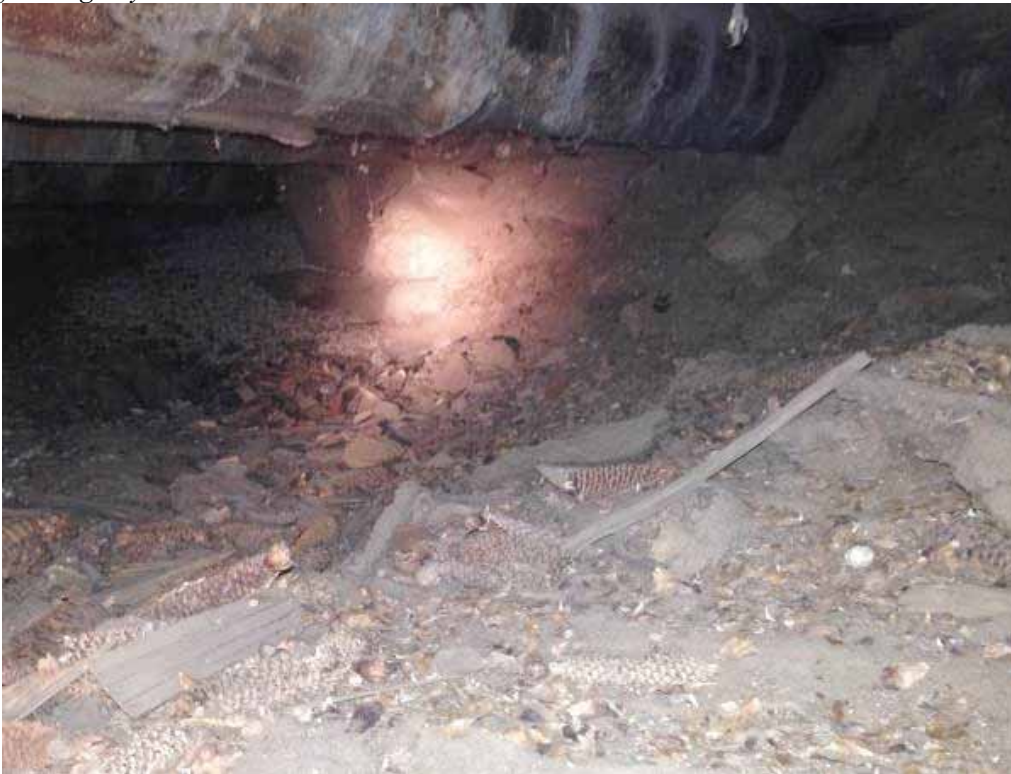
Photo 3.2-6: Loose stack of stones supporting the chimney above

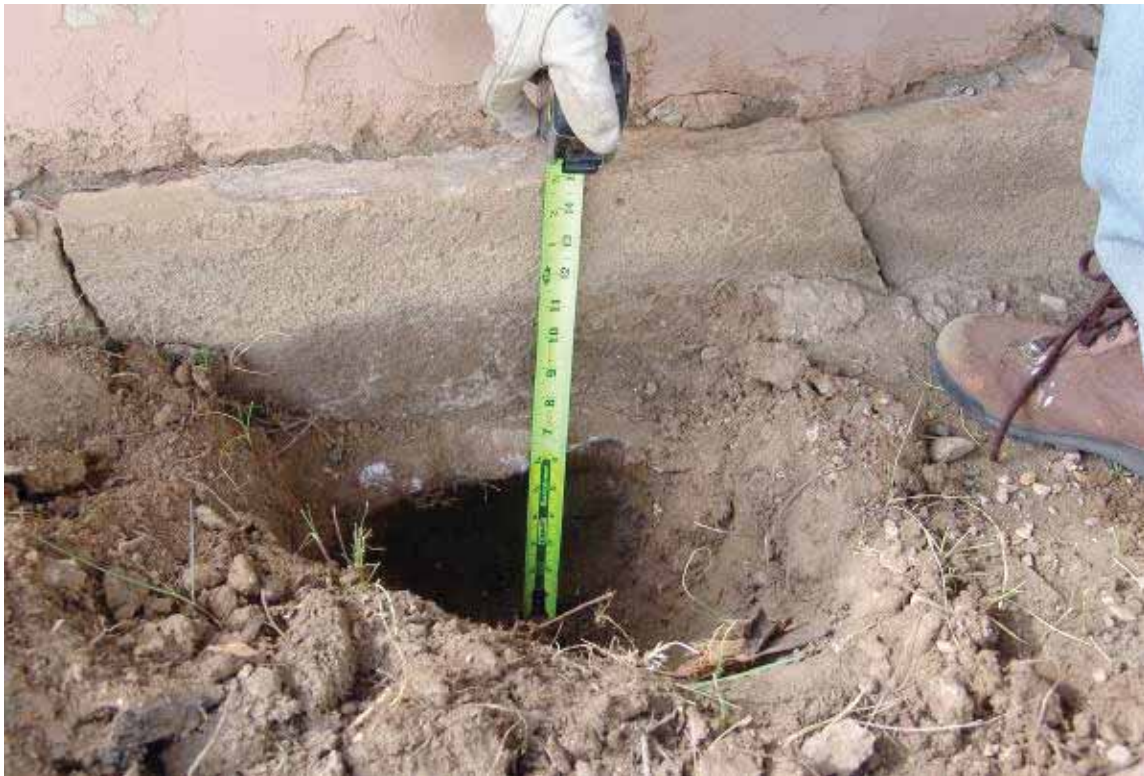
The rubble stone foundation supporting the perimeter walls of the lean-to south addition (Room 3) appears to be only one course high. At this bearing elevation just below grade, the soils are more prone to moisture cycles than the soils at lower elevations. Consequently, the base course of stones is more prone to settlement when soils are wetted and weakened, and more prone to heaving when the wetted soils freeze, in comparison to the more substantially constructed foundation around the main portion of the structure. As discussed in Section 3.4, there is evidence that the lean-to addition has settled downward relative to the main building. The entire addition is constructed skewed, as seen in the measured floor plan in Section 2.7 and below.

Photo 3.2-7: Depth of foundation as measured from exterior exploratory excavation along south elevation of lean-to addition

- Similar to the foundation around the main structure, the foundation around the lean-to addition should be exposed on both sides so that it can be repaired. Pending the objectives of the stakeholders and the final treatment of the lean-to addition, it may be appropriate to replace the existing foundation with a conventional reinforced concrete footing and stem wall. (Serious)

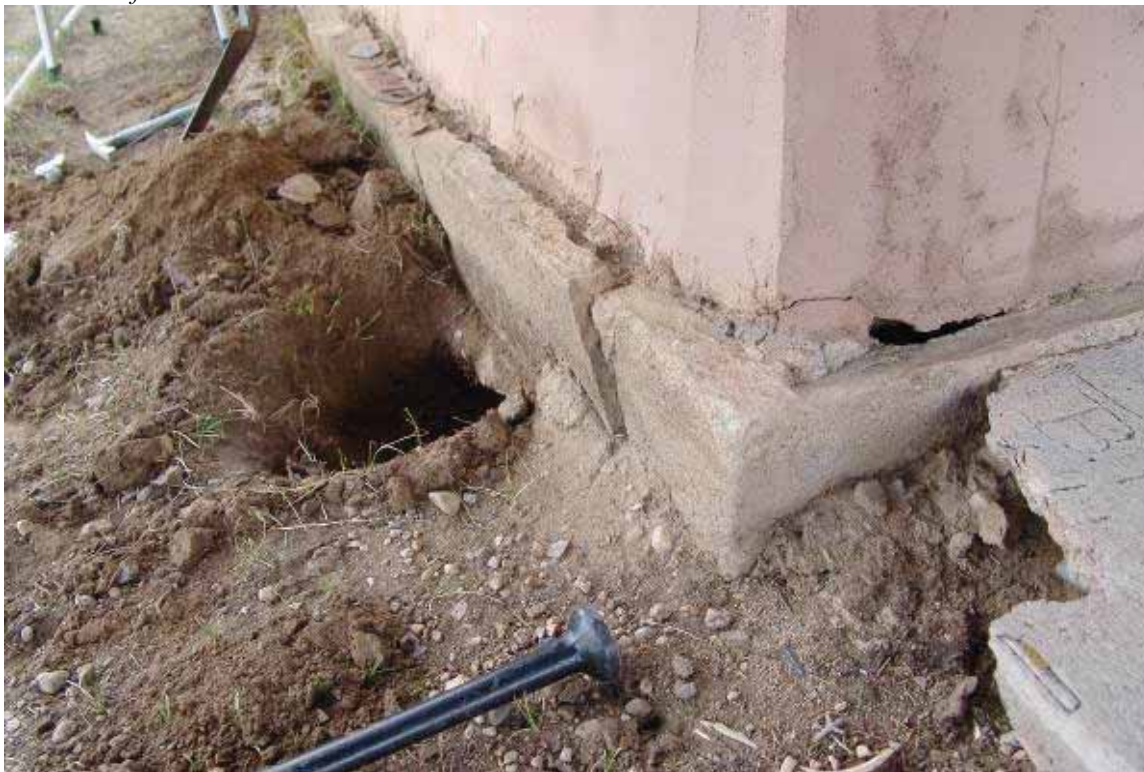
Photo 3.2-8: Concrete curb/parge coat along base of south addition exterior walls

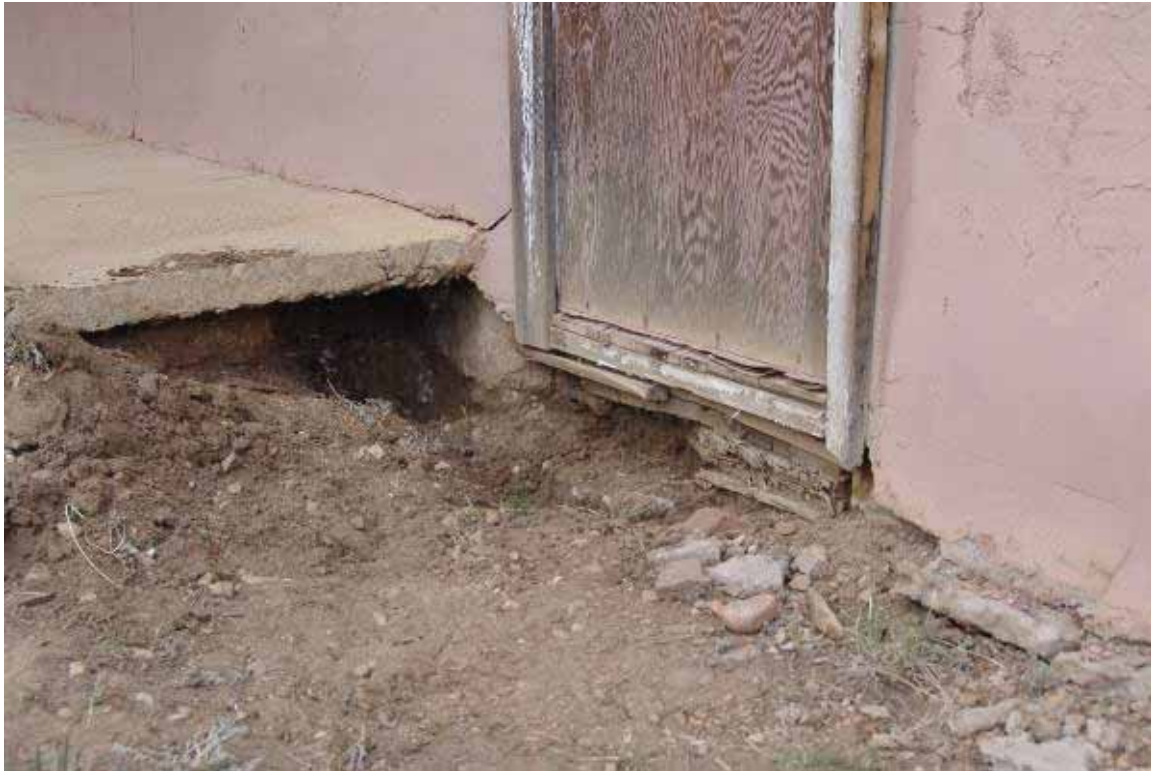
Photo 3.2-9: West elevation of south addition. Note multiple layers of floor sheathing and threshold elevation relative to apron slab

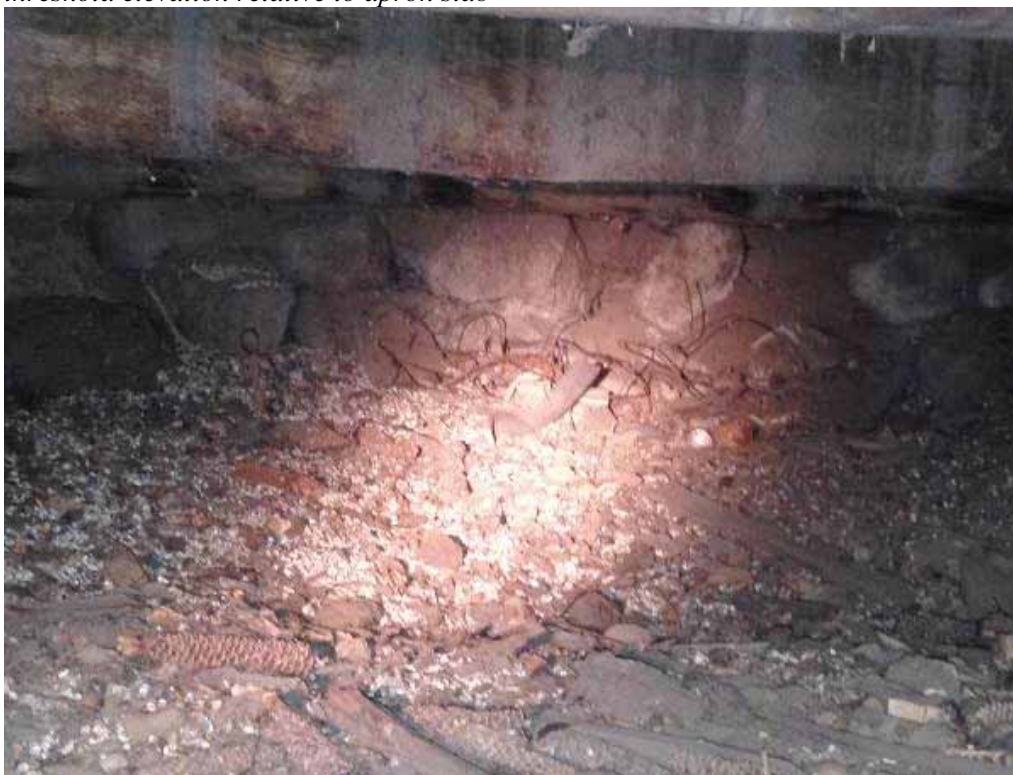
Photo 3.2-10: Inside face of stone foundation wall along west elevation of main building in south bay

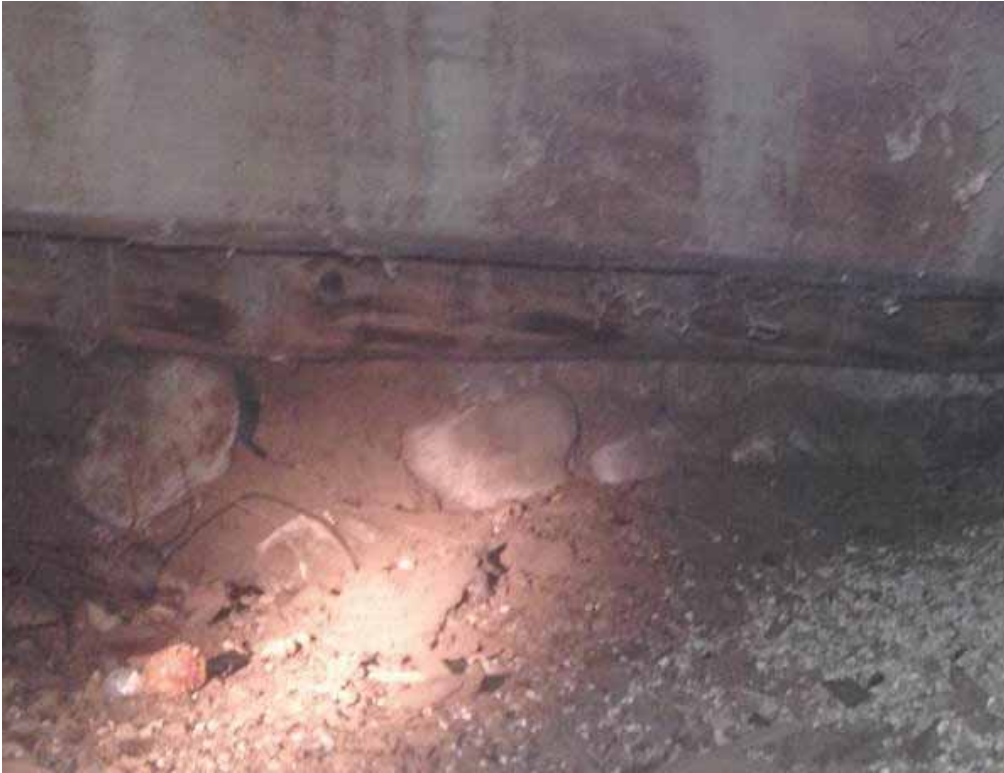
Photo 3.2-11: Inside face of stone foundation wall along east elevation of main building in south bay below Room 2

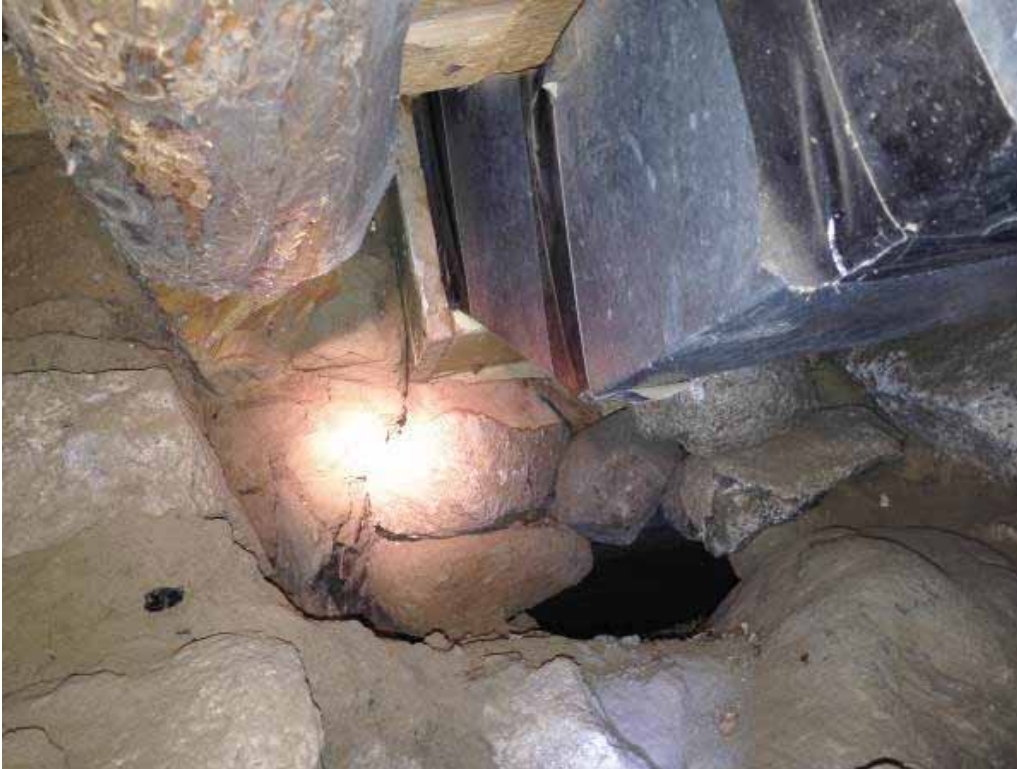
Photo 3.2-12: Inside face of stone foundation wall along south elevation of main building in south bay below Room 2. Note that opening made for duct has undermined the log floor joist.

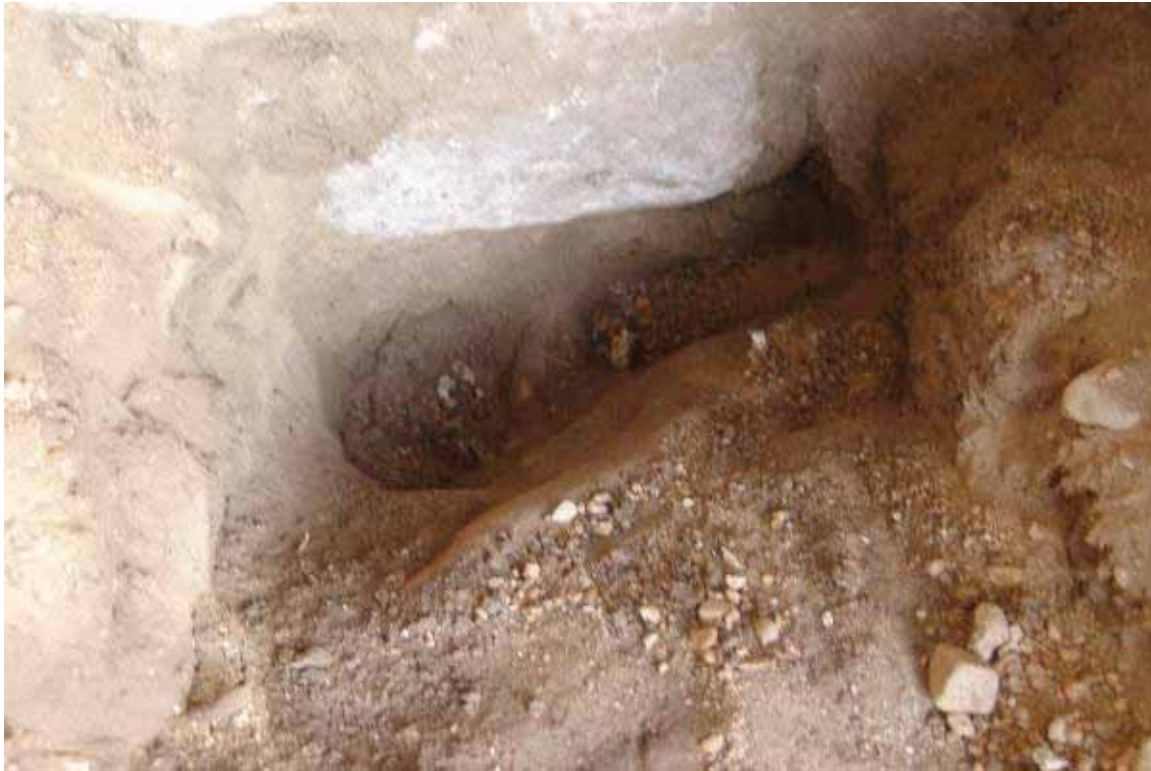
Photo 3.2-13: Base of foundation wall along north elevation. Note that tree root is oriented parallel to foundation wall and that it has not displaced the immediately adjacent stones.

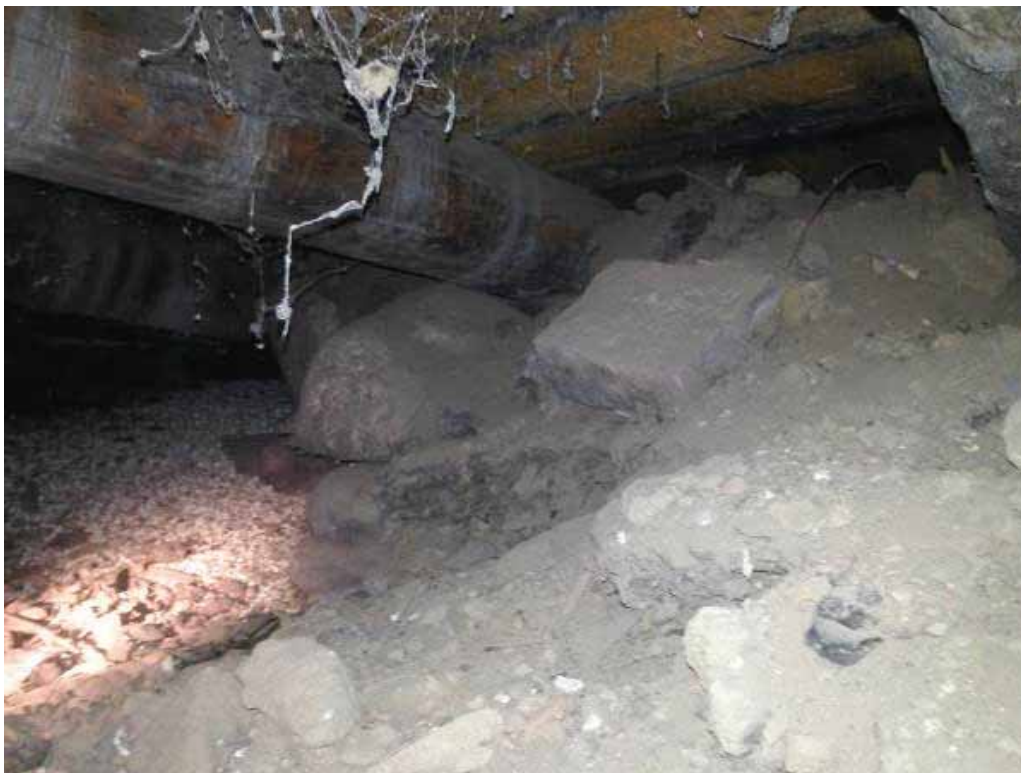
Photo 3.2-14: Rubble stone footing beneath chimney has spilled outward into the crawlspace

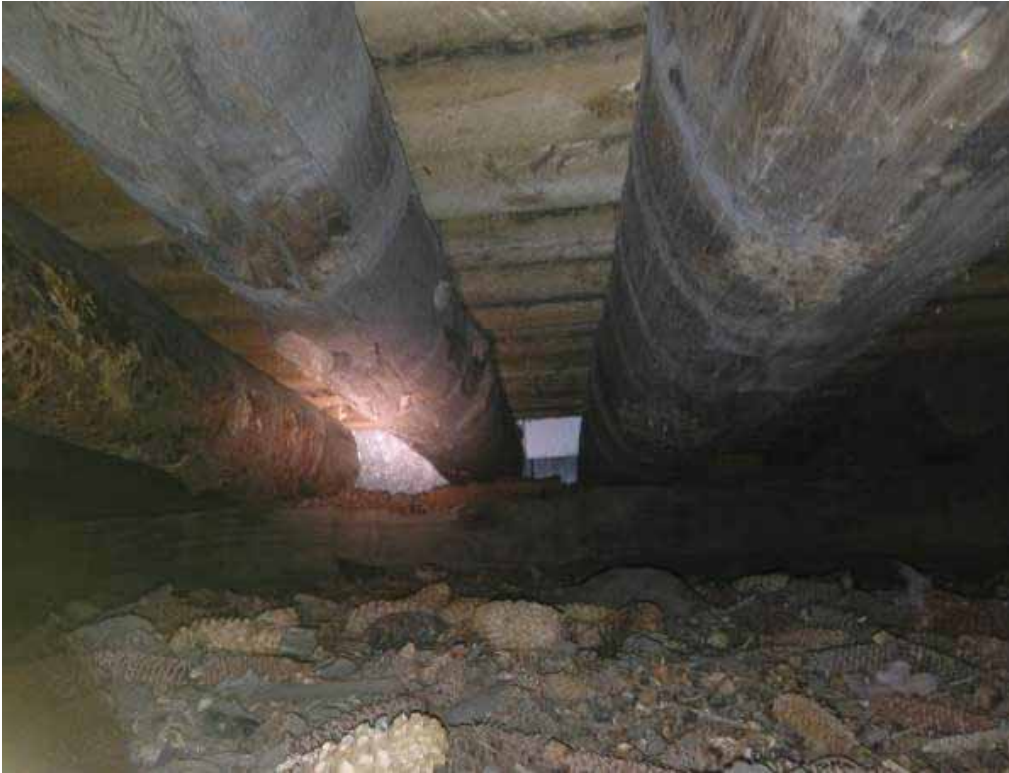
Photo 3.3-1: First floor log joists in the south bay of the main building looking north at log sill

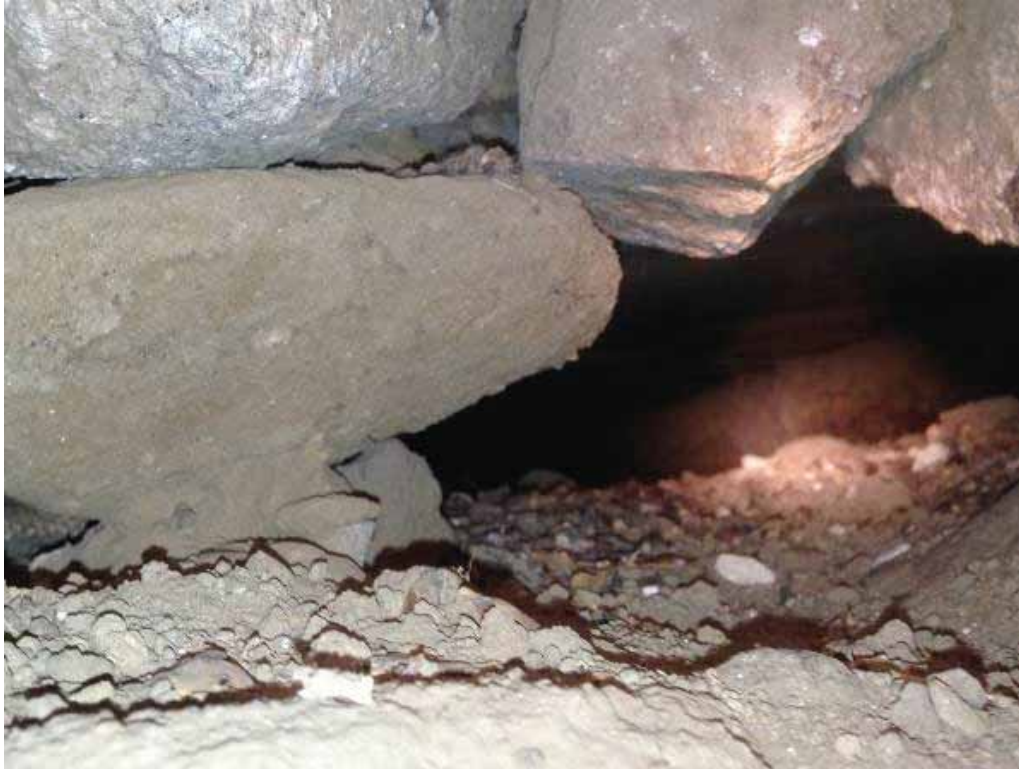
Photo 3.3-4: Log joist resting on or near crawlspace soils faintly visible in background beyond hole in foundation wall.

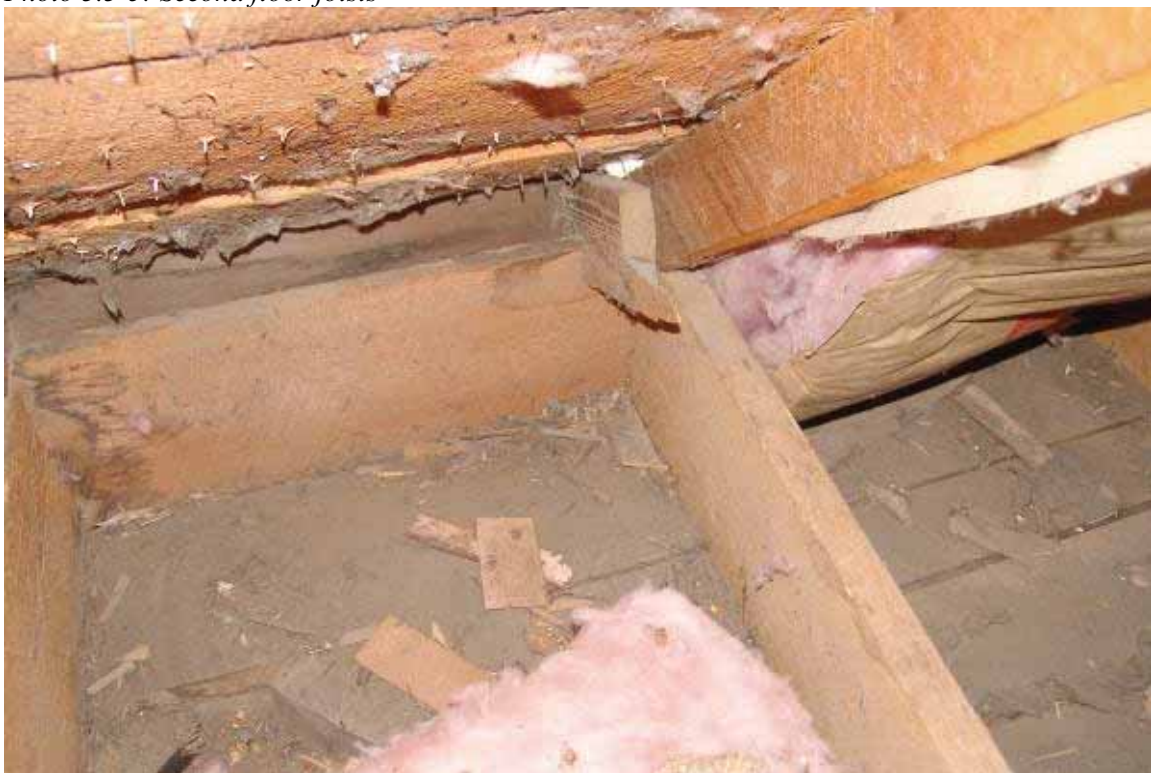
Photo 3.3-6: Second floor joists bearing on adjacent plates over adobe wall. Note also rim board, rafter, and back of porch rafter notched over rim board

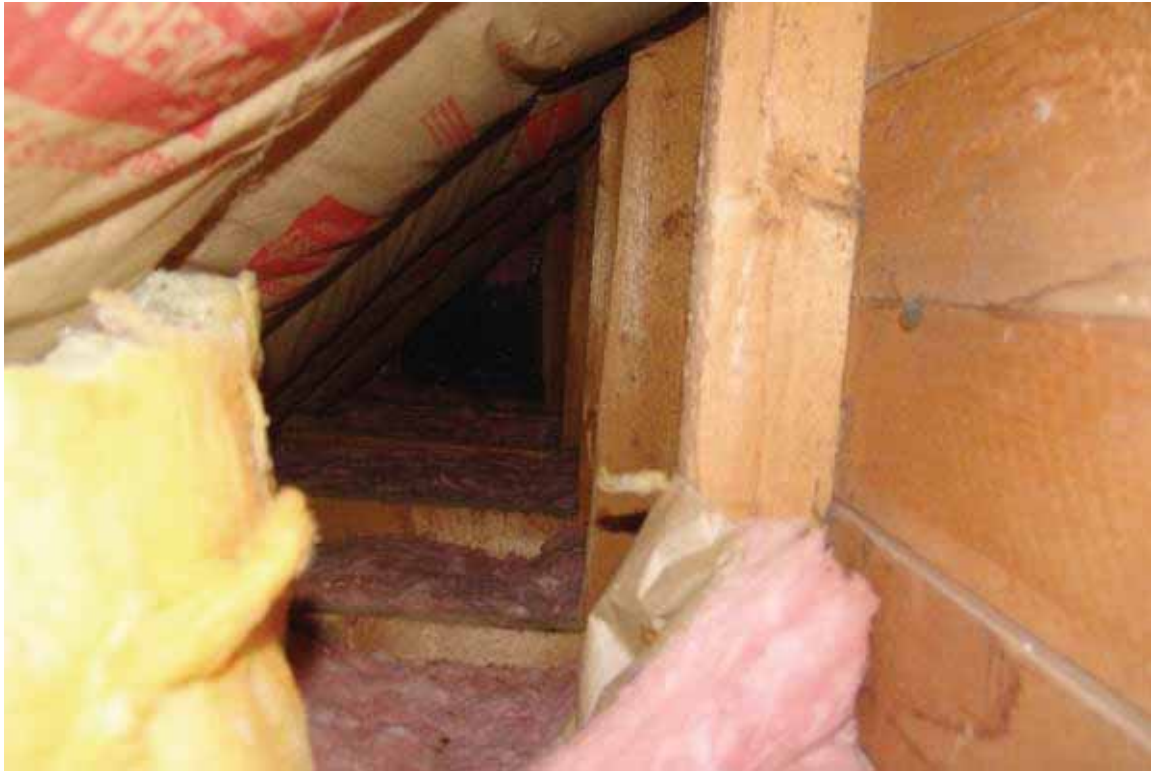
Photo 3.3-9: Dead space along east and west sides of second floor. Note cripple studs supporting rafters and unsheathed second floor rafters

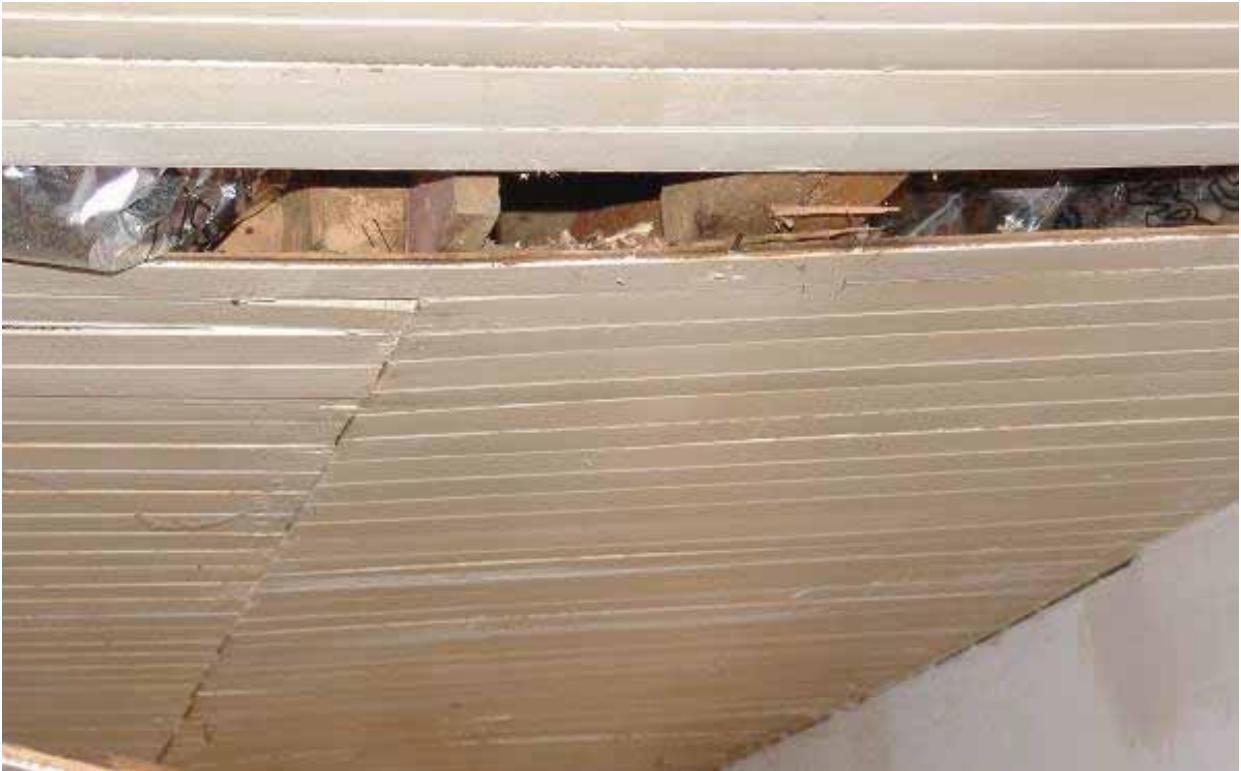
Photo 3.3-11: Seam in ceiling representing possible end of former load-bearing interior wall, Room 2. Discontinuous joist end visible at aperture in ceiling.

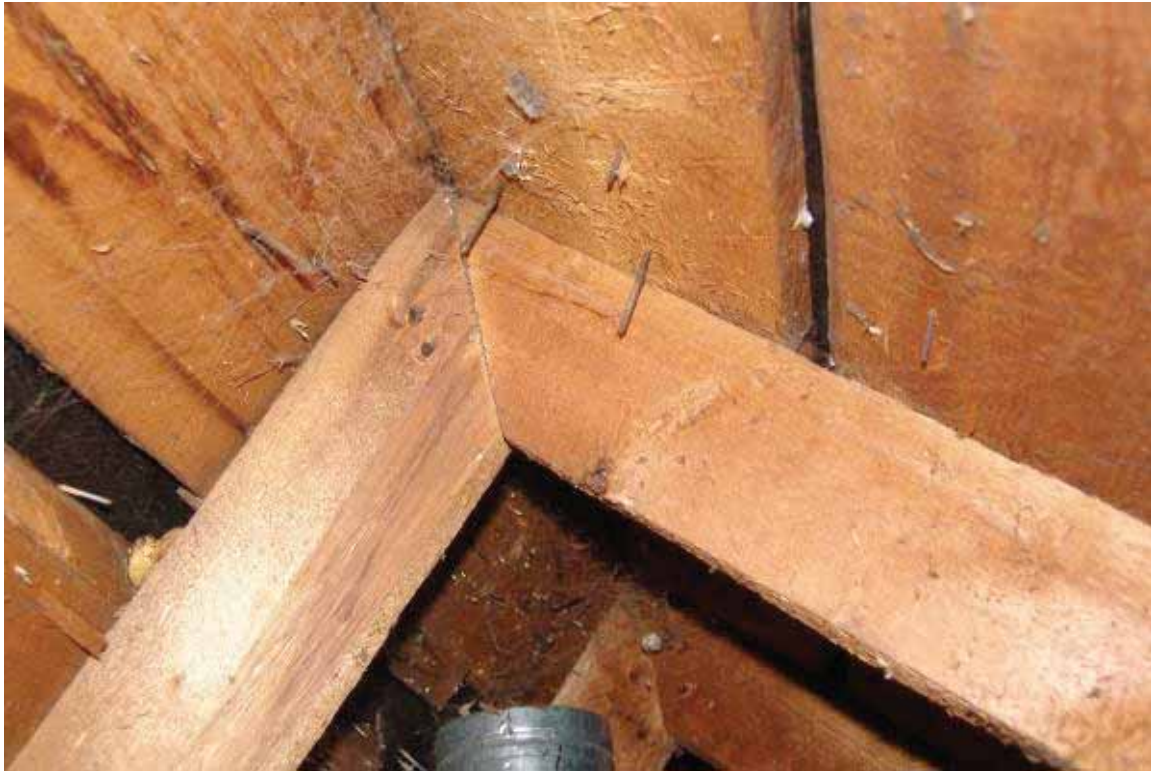
Photo 3.3-12: Ridge of the main building roof. Note the lack of a ridge board and the two toenails

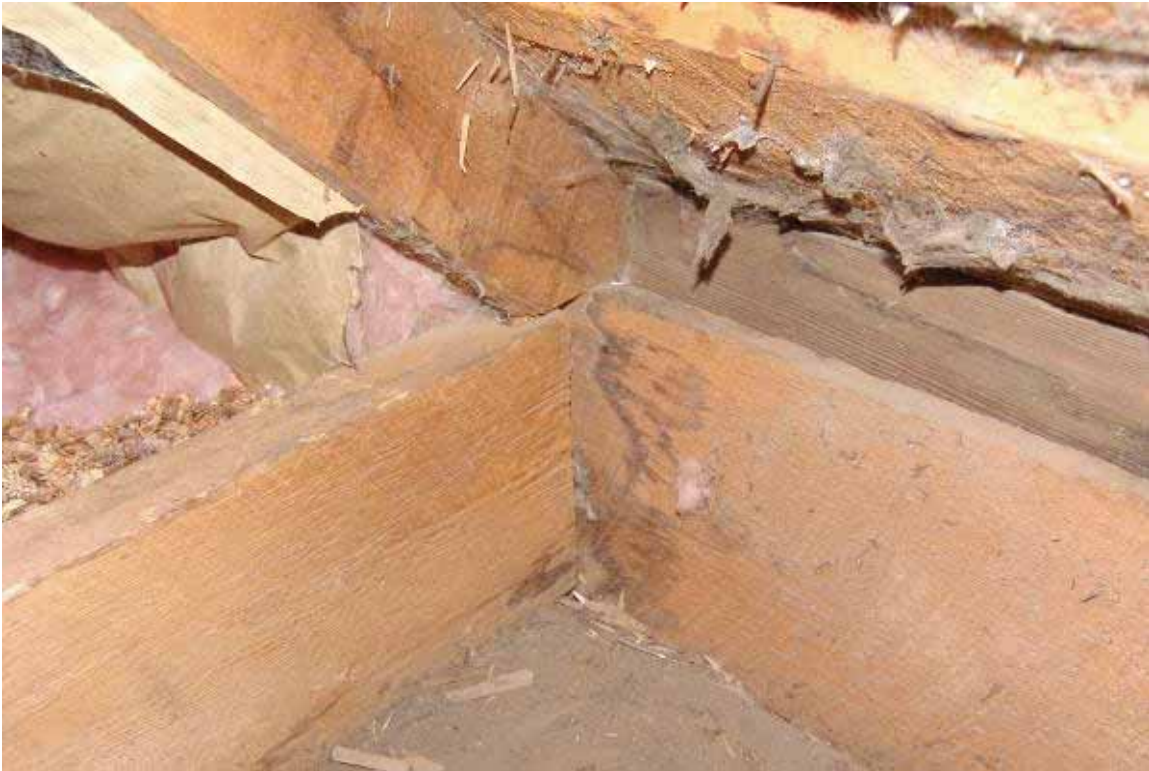
Photo 3.3-13: Main building rafter to joist connection with four side nails.

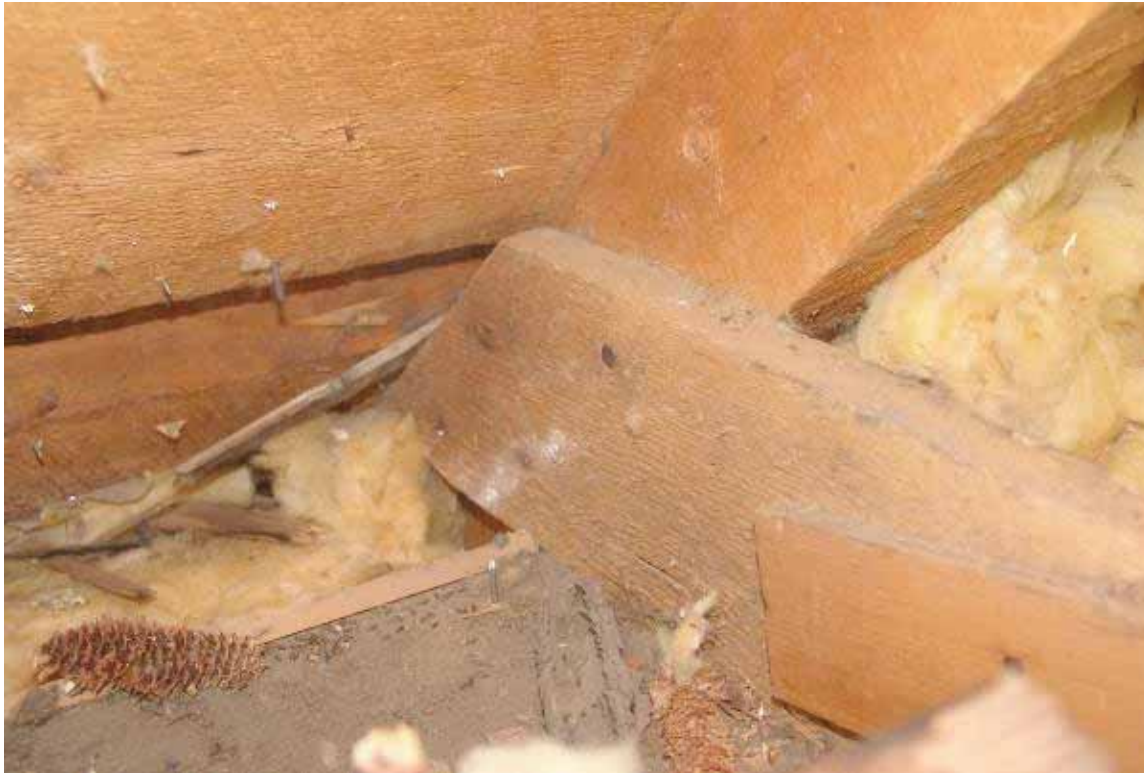
Photo 3.3-15: Main building rafter to collar tie connection with four side nails.

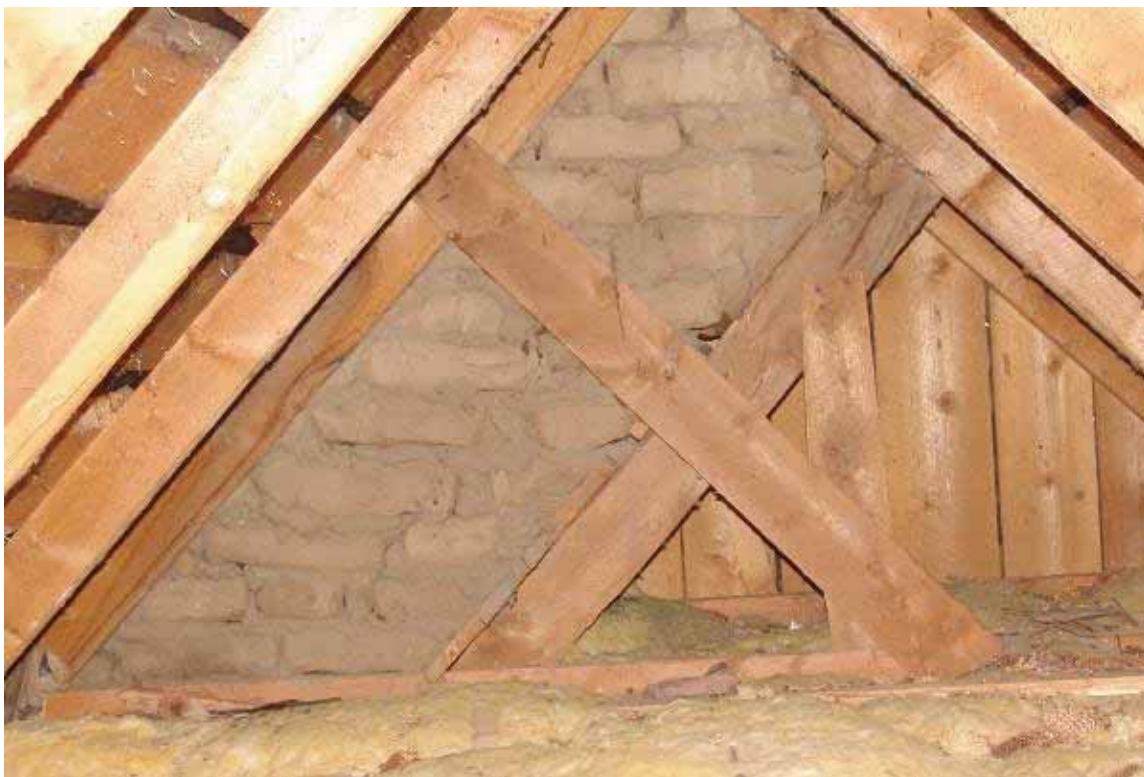
Photo 3.3-16: Struts supporting battered adobe chimney at south end of attic
