CLARION HOTEL
TWIN LAKES, CO
HISTORIC STRUCTURE ASSESSMENT

PREPARED FOR:
FRIENDS OF TWIN LAKES
SHF 14-HA-008
FEBRUARY 5, 2015
DELIVERABLE #5

SHF 14-HA-008
FEBRUARY 5, 2015
5LK.41

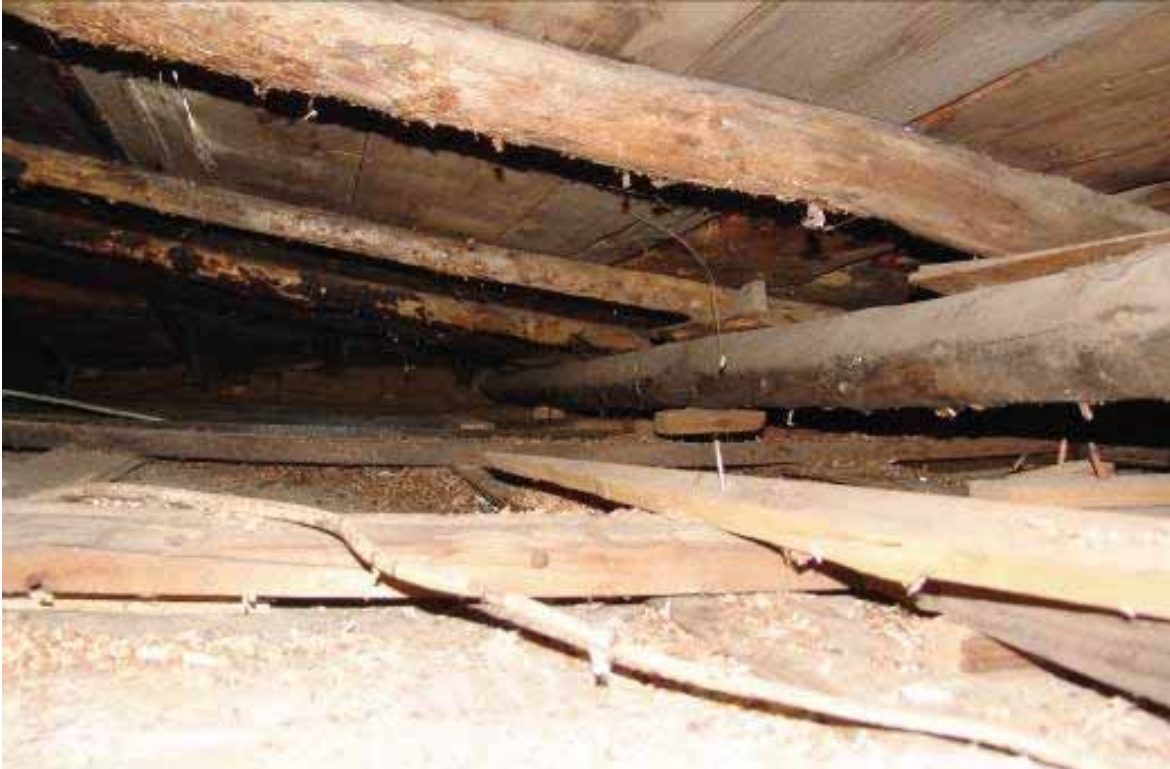
Photo 3.3-19: Dropped log purlin and rafters at the south lean-to addition above Room 3

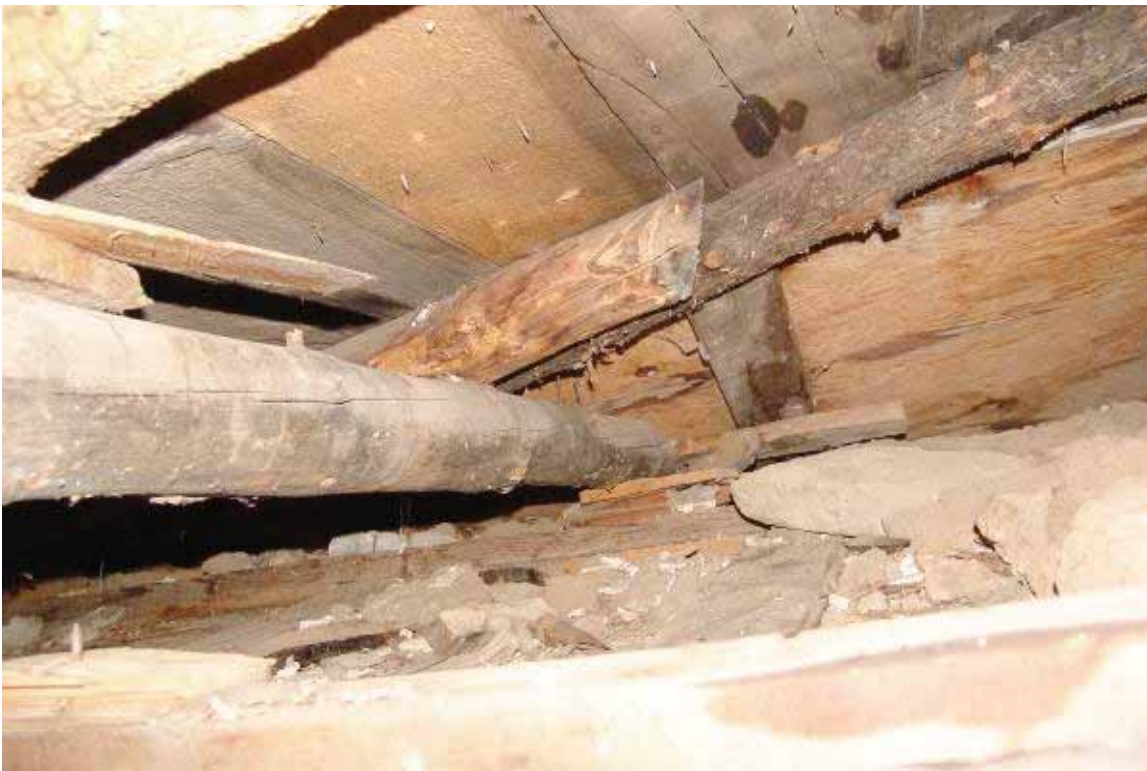
Photo 3.3-20: Log hip and flat 2x4 rafter at south lean-to addition hip above Room 3

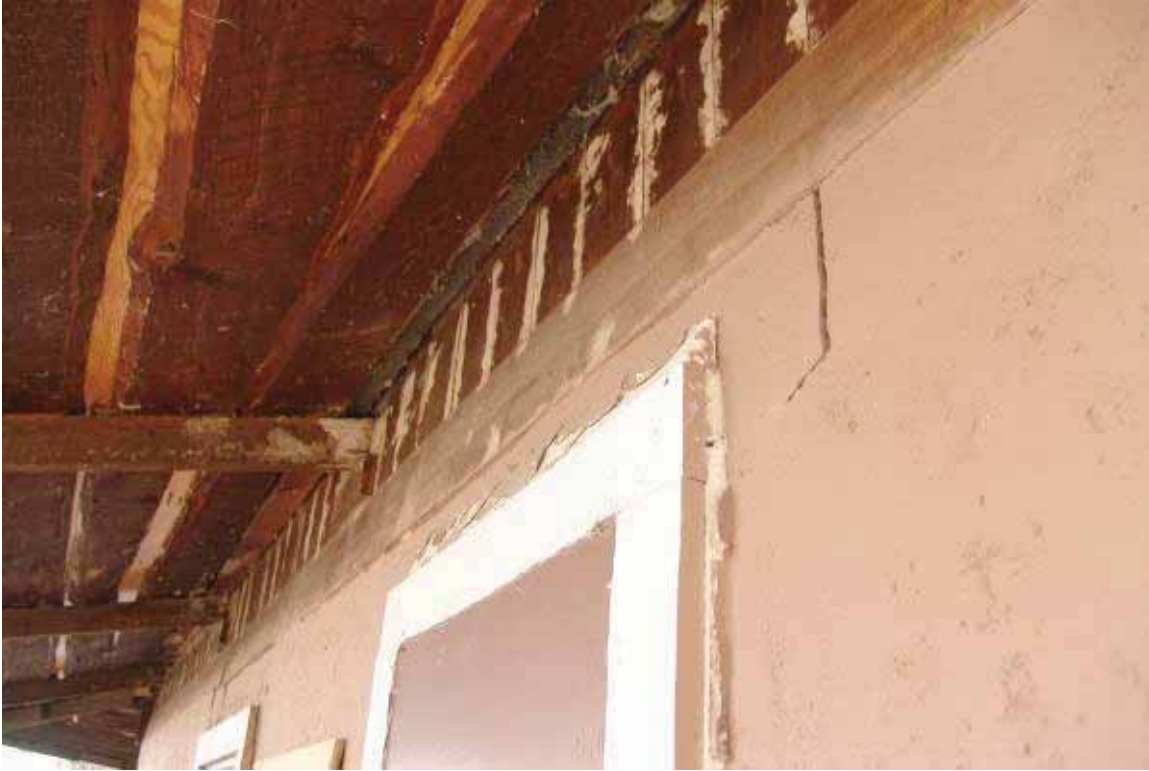
Photo 3.4-10: Cracks in stucco at door and window head corners along north elevation

- Remove delaminated areas of plaster/stucco and replace compatible material. (Serious)
- Remove incompatible areas of plaster/stucco and replace with compatible material. (Serious).
- Remove all plaster on the south wall of the lean-to and rebuild the collapsed sections. Correct roof leaks and apply compatible stucco/plaster. (Critical)
- Replace gable siding on south gable and south side of west dormers. (Serious)
- Paint entire exterior following repairs. (Minor)

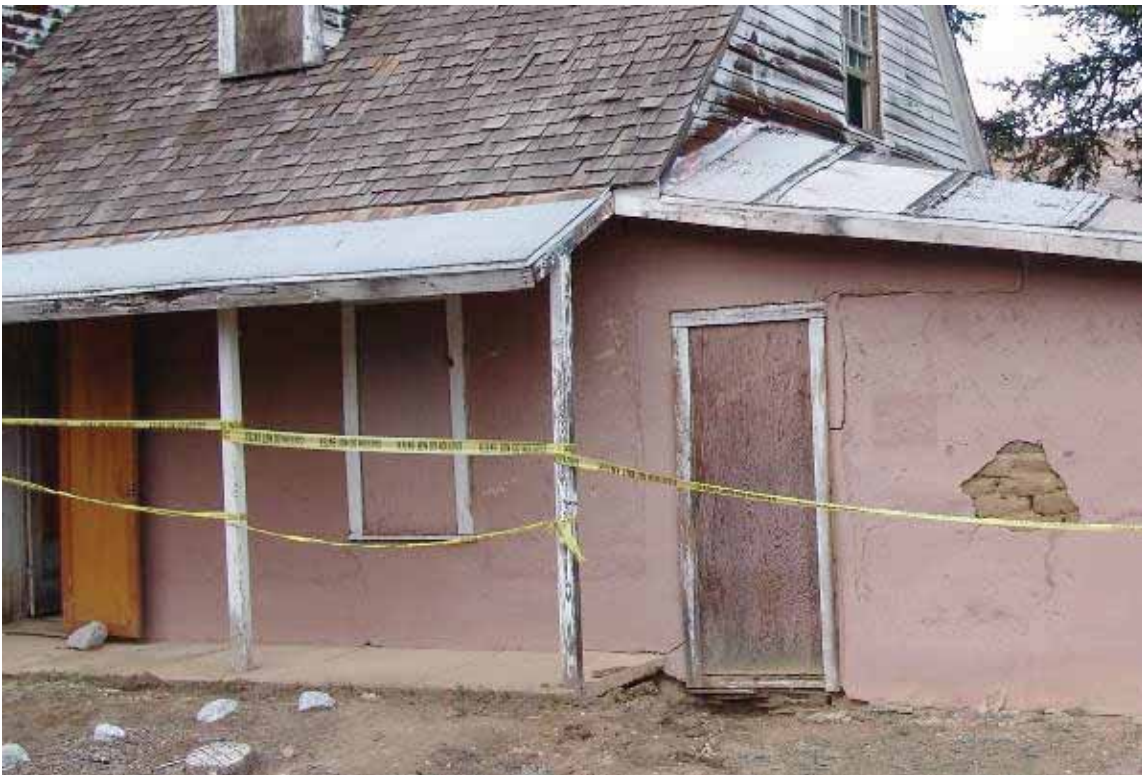
Photo 3.4-11: Stair step crack along west elevation. Crack originates at edge of slab where foundation discontinuity and rotation is suspected.

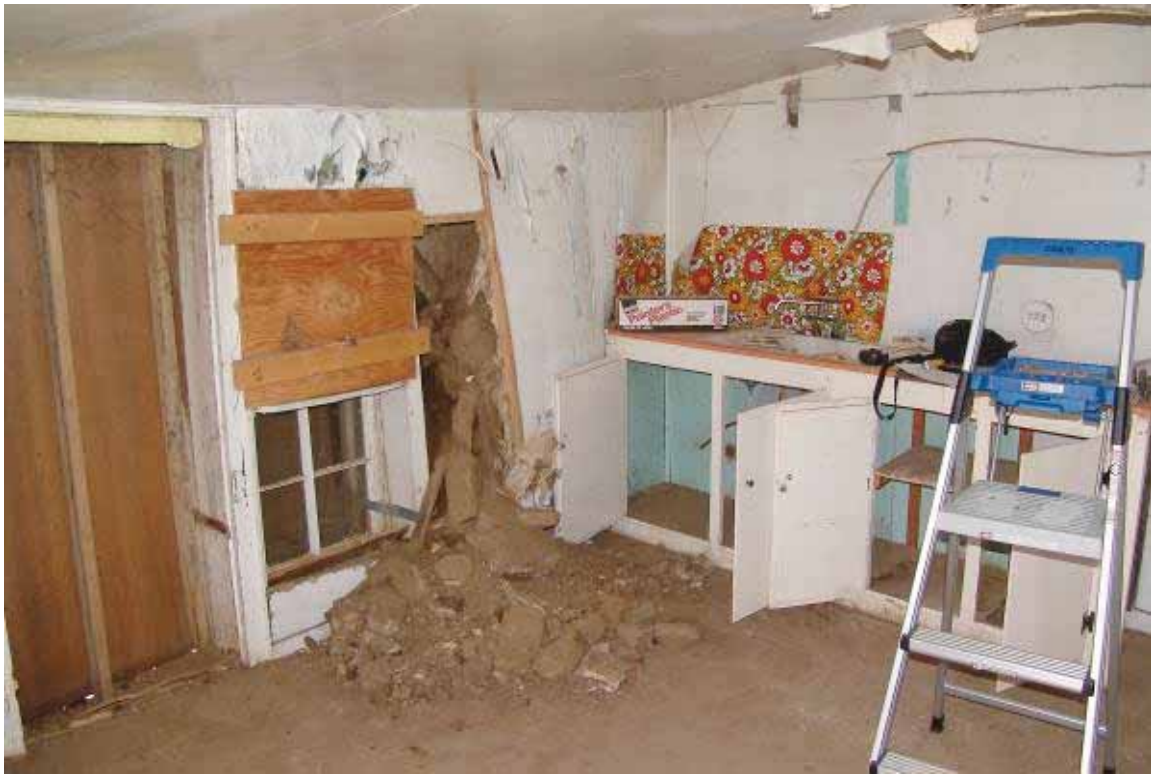
Photo 3.4-12: Collapsed south wall of lean-to addition (inside Room 3)

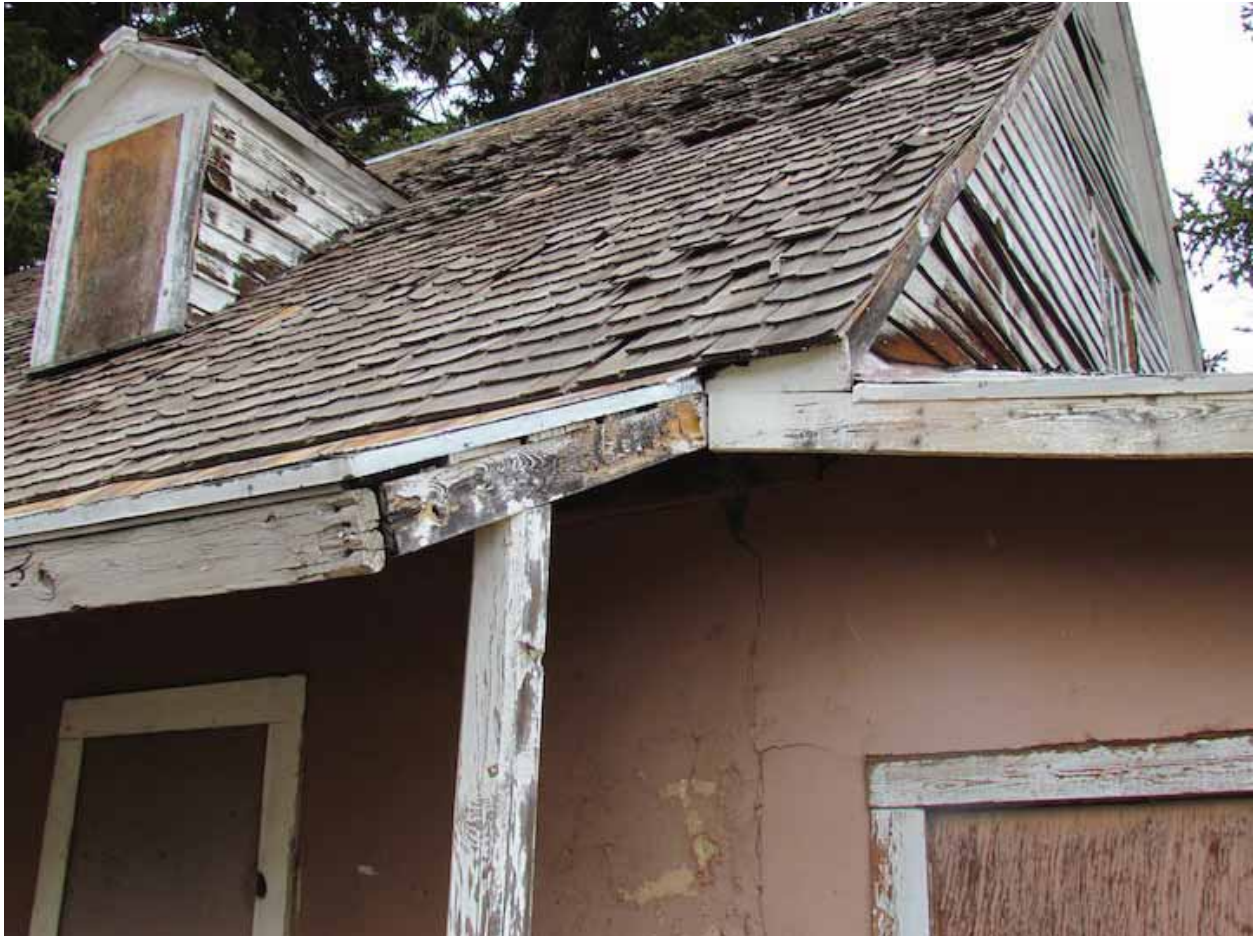
Photo 3.5-1. West side dormer, south side gable siding, west side fascia and roofing.

- Replace south gable trim. (Serious)
- Replace south gable siding. (Serious)
- Replace/splice 5 split exposed rafters, west side, below porch roof. (Serious)
- Replace all trim, all dormers. (Serious)
- Replace siding, south-facing dormer walls, west side. (Serious)
- Replace roofing, southern dormer, west side. (Serious)
- Flash dormers to main roof. Flash all dormers walls to dormer roofs. (Serious)
- Replace loose plaster on chimney. (Serious)
- Rebuild south addition roof. Some framing may be salvageable. (Critical)
- Replace entire porch roof structure. Some framing members may be salvageable. (Critical)

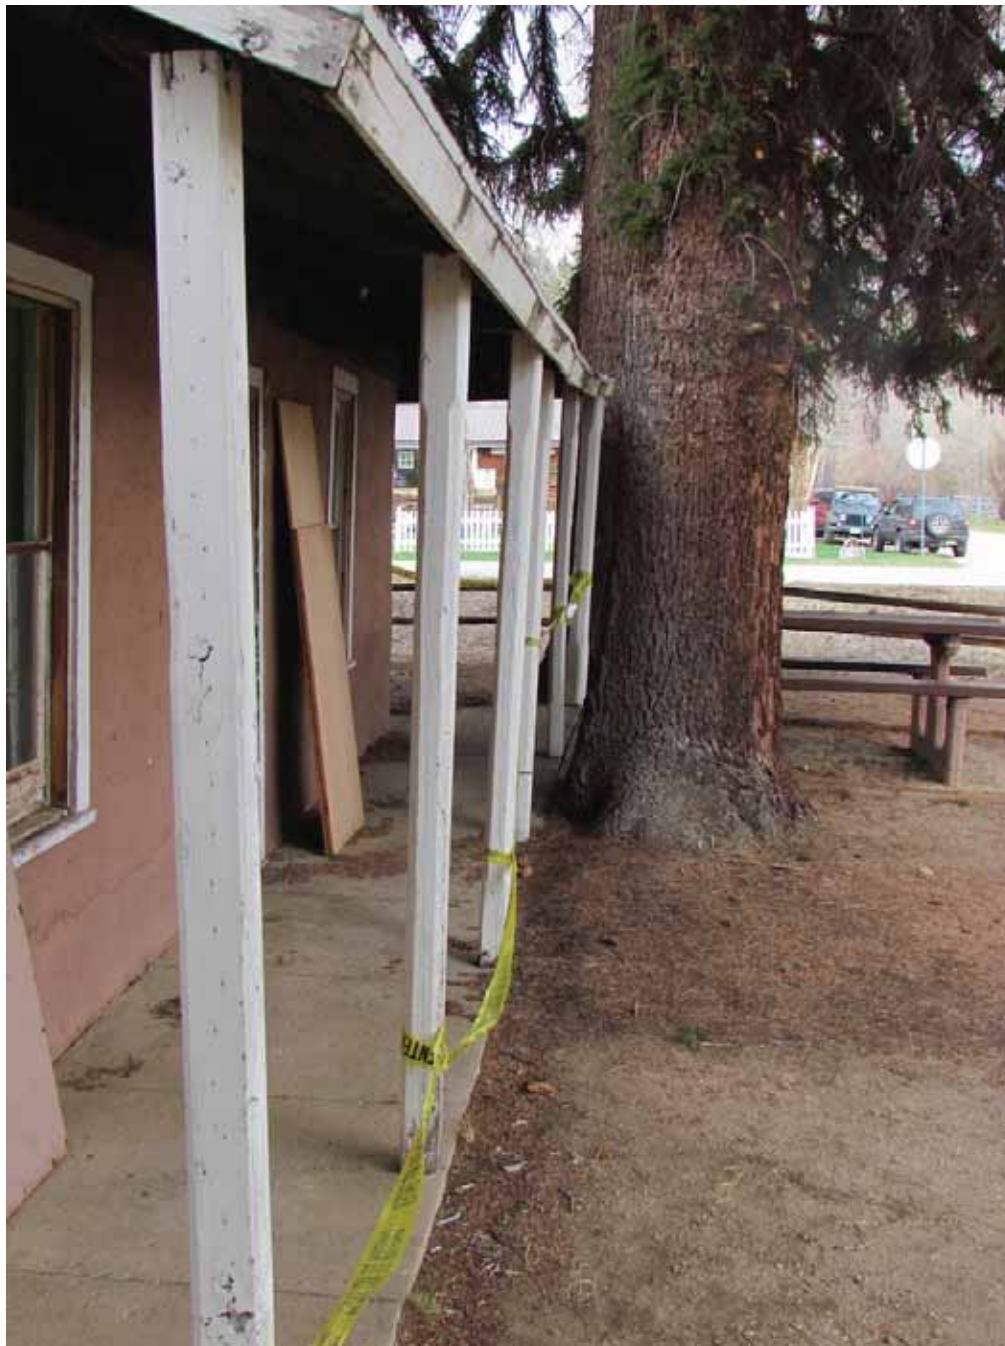
Photo 3.5-2 showing north porch roof deflection.
