CLARION HOTEL
TWIN LAKES, CO
HISTORIC STRUCTURE ASSESSMENT

PREPARED FOR:
FRIENDS OF TWIN LAKES
SHF 14-HA-008
FEBRUARY 5, 2015
DELIVERABLE #5

SHF 14-HA-008
FEBRUARY 5, 2015
5LK.41

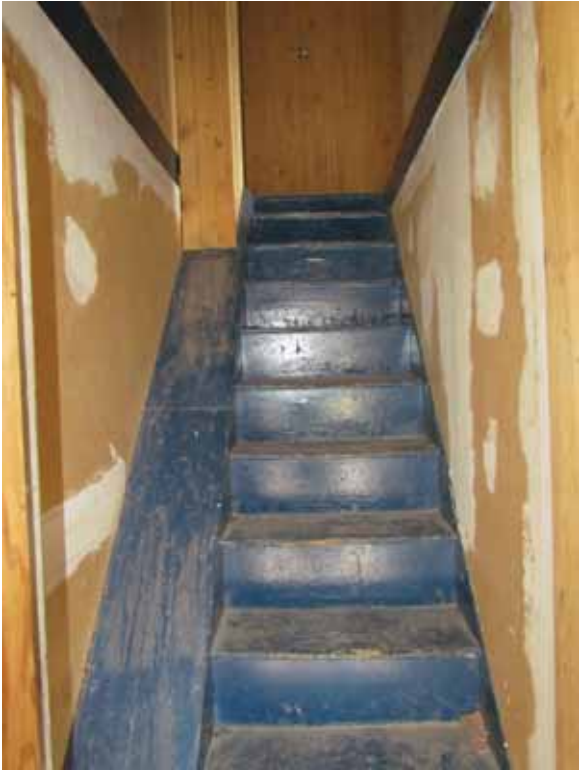
Photo 2-11. Looking up historic stair. Enclosure has been widened to accommodate furnace flue.

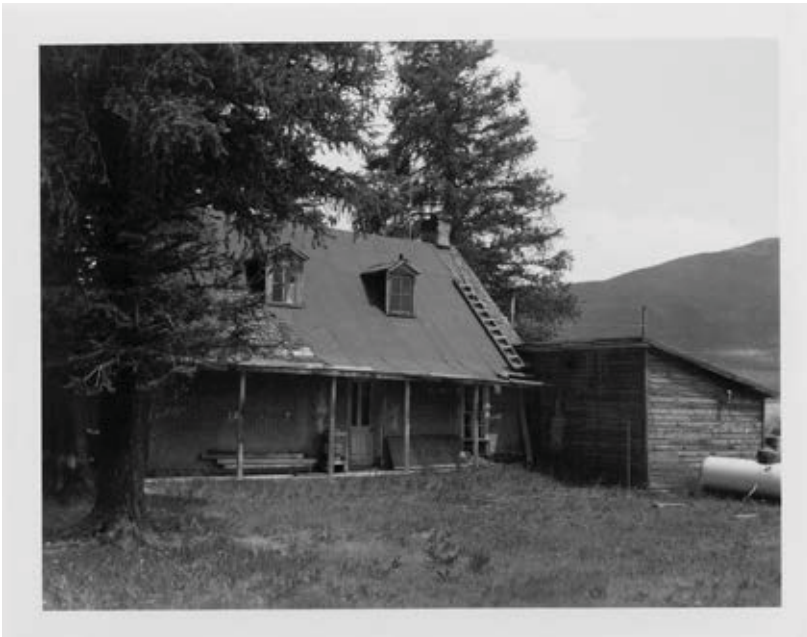
Photo 2-15. 1974 National Register nomination photo shows two dormers and a shed-roofed structure with wood siding on the south side of the main building. The nomination notes that the building has brick facing.

The 1974 National Register nomination notes that the exterior walls are finished with brick, although it is difficult to discern that in the associated photograph. (Photo 2-15). This may explain the light score lines visible on the west elevation, which may have been drawn as coursing guides for the brick installation. There is no other physical evidence of brick.

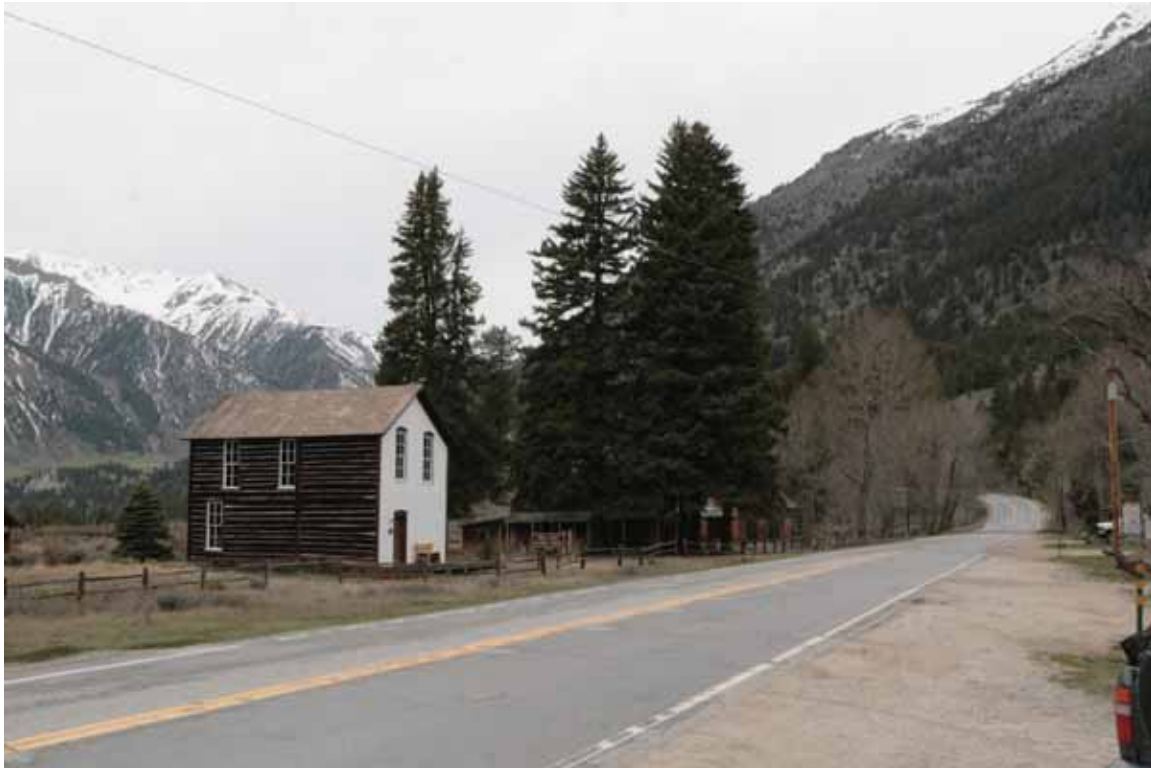
Photo 3.1-1. Looking southwest at Visitor Center showing site setting. Clarion is to the right of the Visitor Center in its grove of spruce trees.

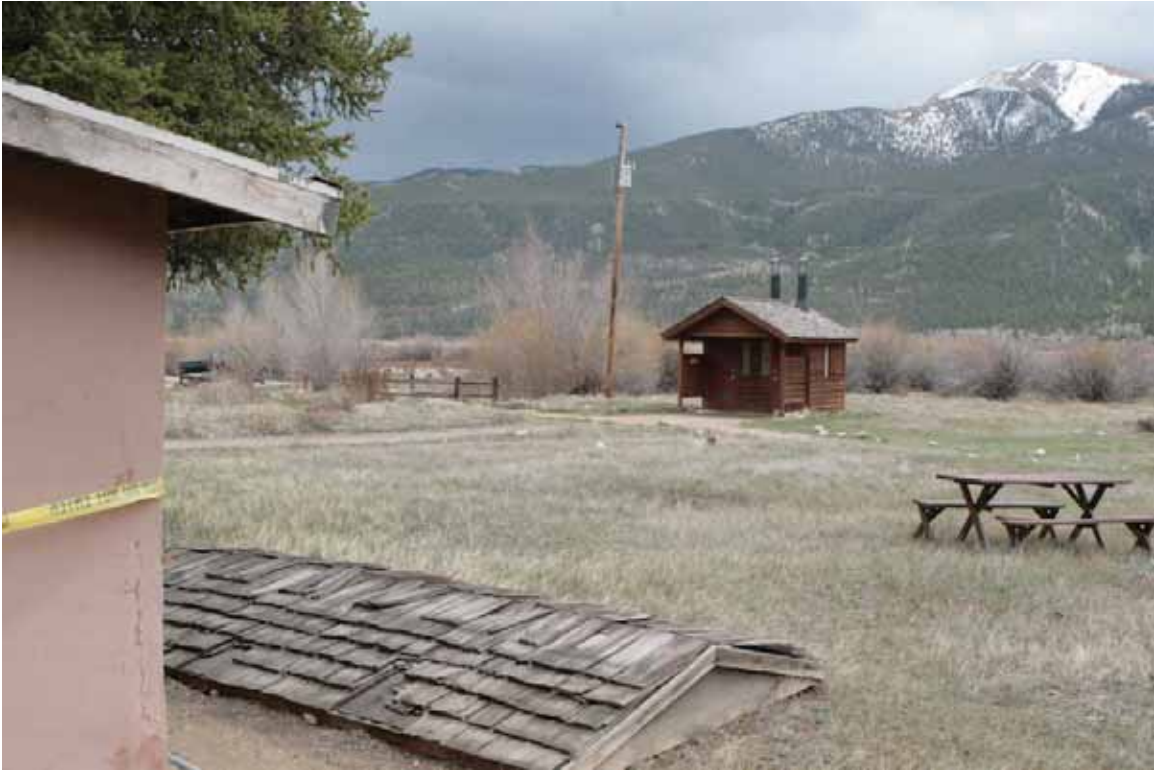
Photo 3.1-2. Looking southeast at wetlands and non-historic toilet building. Just south of the Clarion, a shallow gabled roof with wood shingles covers an unused storage pit.

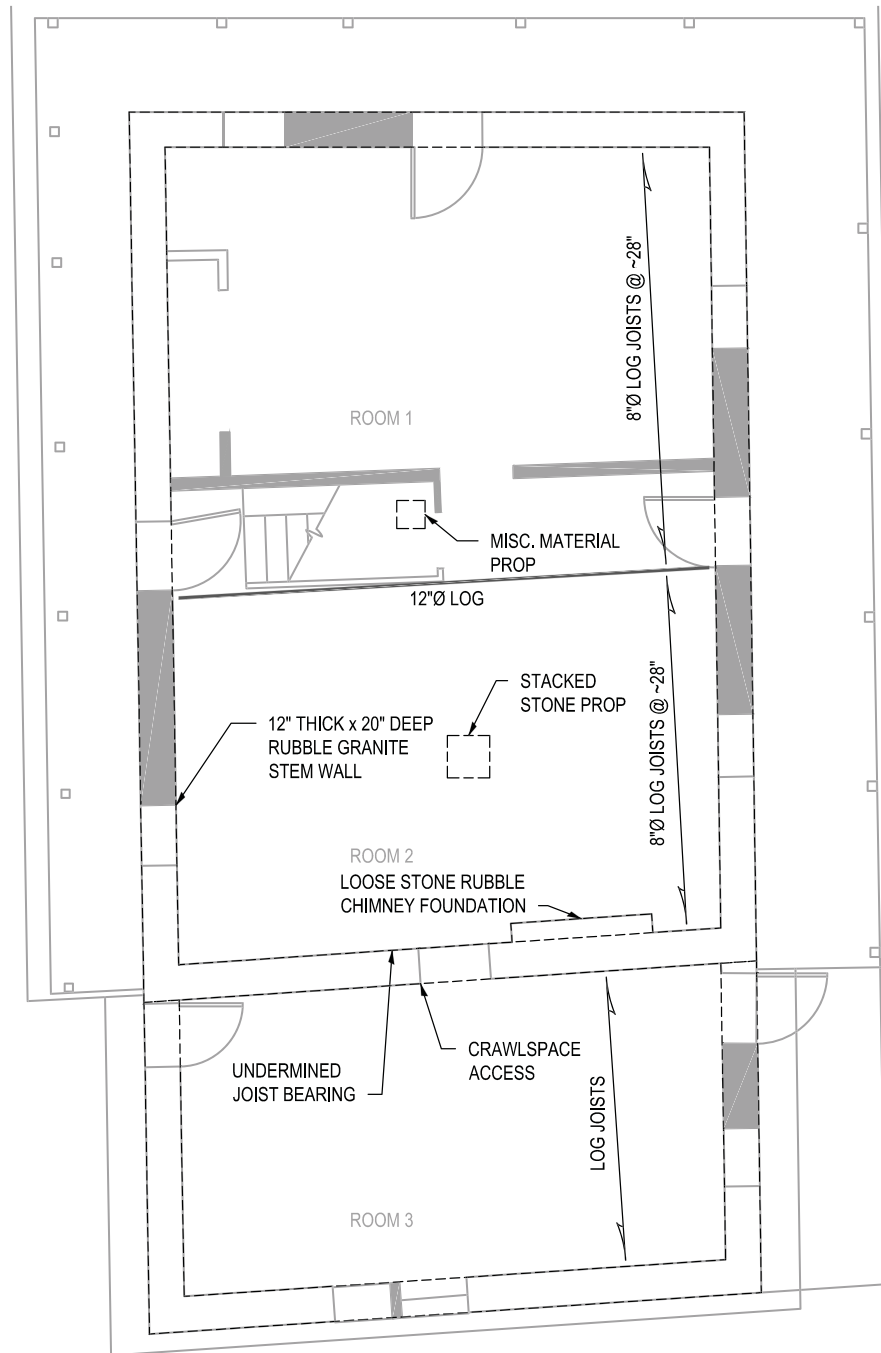
FIRST FLOOR & FOUNDATION PLAN

The rubble stone foundation below the chimney is in poor condition. The individual stones have displaced and the assembly is no longer directly supporting the chimney masonry where it projects north from the gable end wall (Photo 3.2-14). The chimney's masonry is now partially supported by the wood floor framing. The cause of the foundation's poor condition in this area is unknown, but water infiltration into the crawlspace that caused soils subsidence is a possible culprit. The southeast corner of the crawlspace is not accessible or visible, but the foundation wall just to the east of the chimney is presumed to have come apart similarly. The floor in this area is displaced downward substantially indicating that the log joists have moved downward sympathetically with their stone wall support.

The rubble stone foundation supporting the perimeter walls of the lean-to south addition (Room 3) appears to be only one course high. At this bearing elevation just below grade, the soils are more prone to moisture cycles than the soils at lower elevations. Consequently, the base course of stones is more prone to settlement when soils are wetted and weakened, and more prone to heaving when the wetted soils freeze, in comparison to the more substantially constructed foundation around the main portion of the structure. As discussed in Section 3.4, there is evidence that the lean-to addition has settled downward relative to the main building. The entire addition is constructed skewed, as seen in the measured floor plan in Section 2.7 and below.

- Replace or rebuild the foundation below the chimney. This can be accomplished without extensively shoring or reconstructing the chimney by performing the work in stages. The foundation can be reconstructed with mortared rubble stones or with reinforced concrete. (Critical)

- Similar to the foundation around the main structure, the foundation around the lean-to addition should be exposed on both sides so that it can be repaired. Pending the objectives of the stakeholders and the final treatment of the lean-to addition, it may be appropriate to replace the existing foundation with a conventional reinforced concrete footing and stem wall. (Serious)

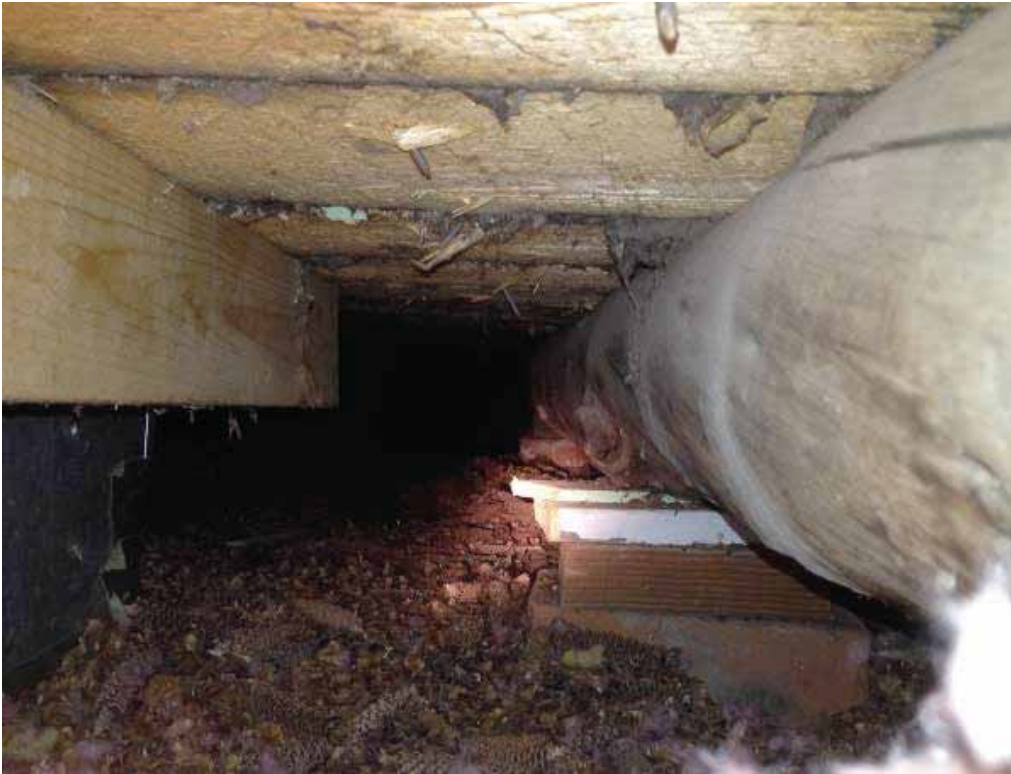
Photo 3.2-5: Isolated adobe, wood, and miscellaneous material log joist support in the north framing bay

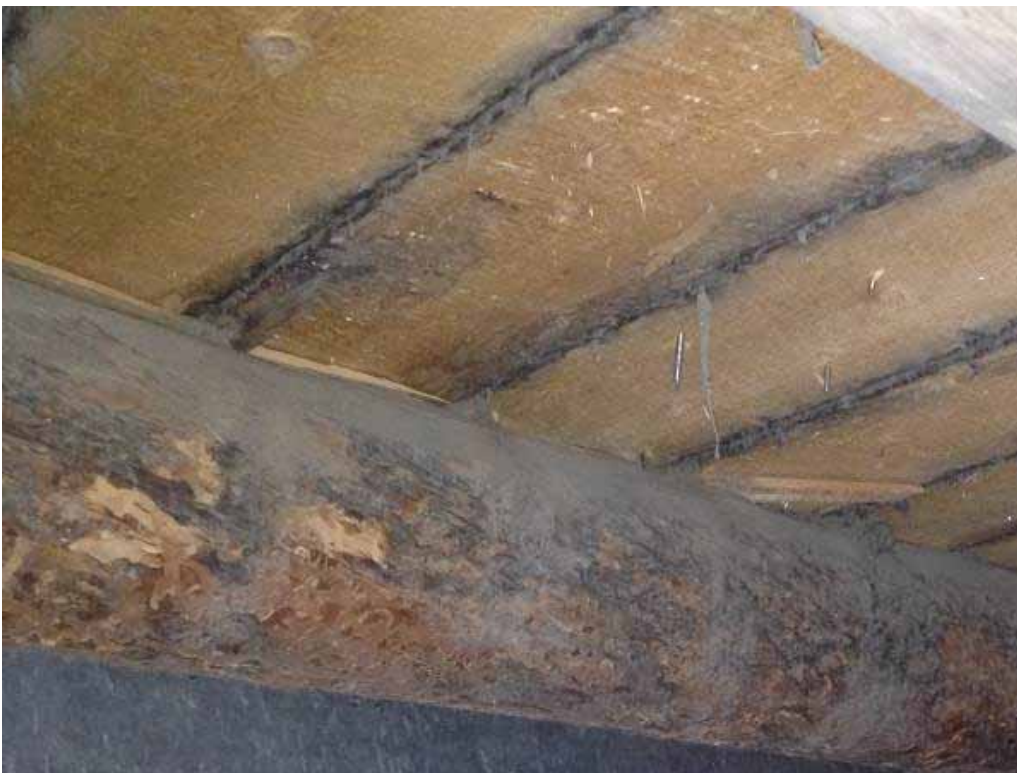
Photo 3.3-2: Top of log is shimmed where floor decking bears

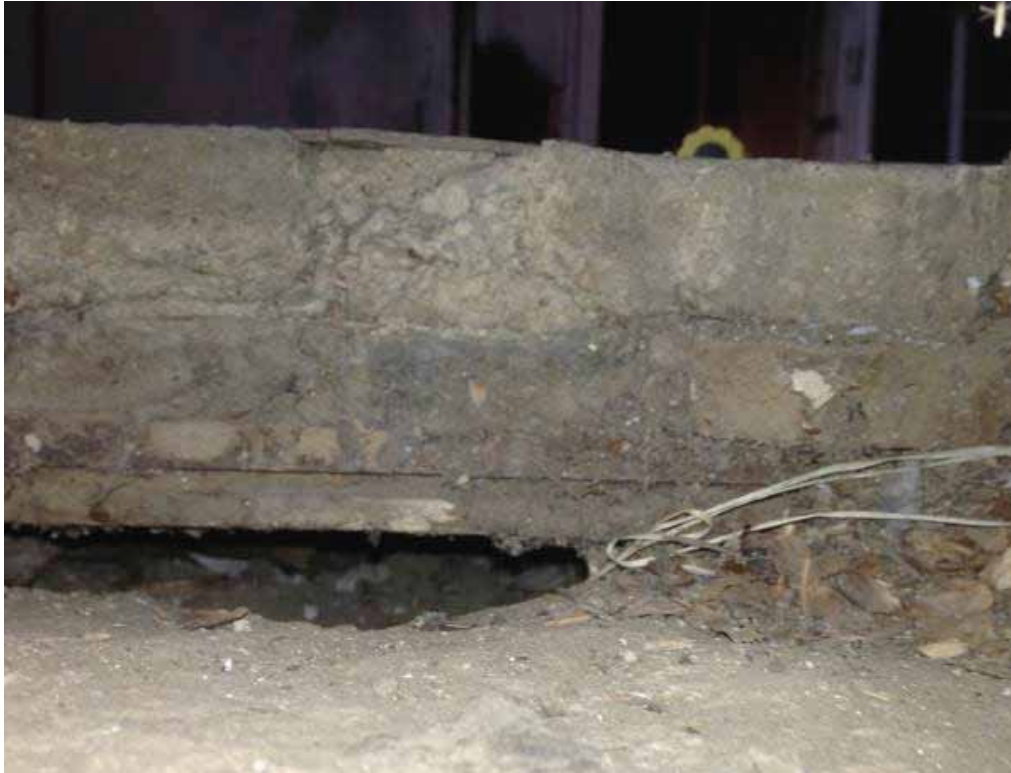
Photo 3.3-3: Cross section of floor sheathing and finishes in lean-to addition under Room 3. Note upper layer of concrete.

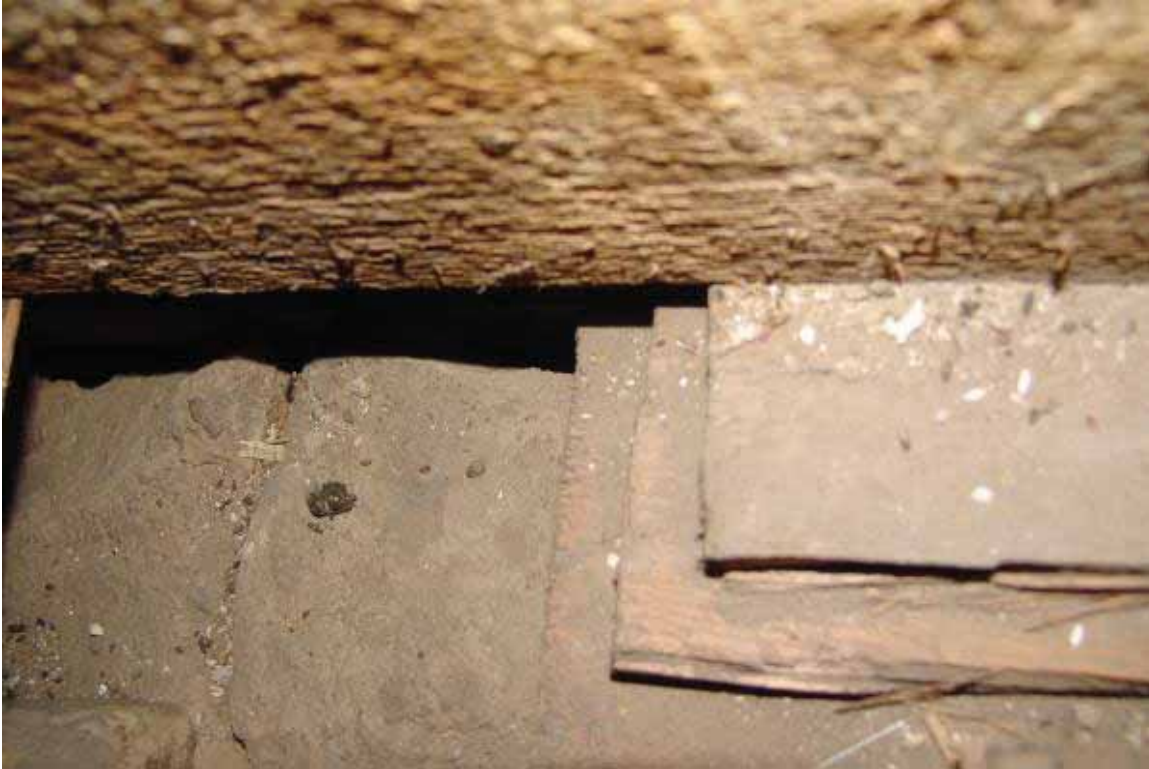
Photo 3.3-7: Second floor end joist bearing on wood shim stack over adobe wall

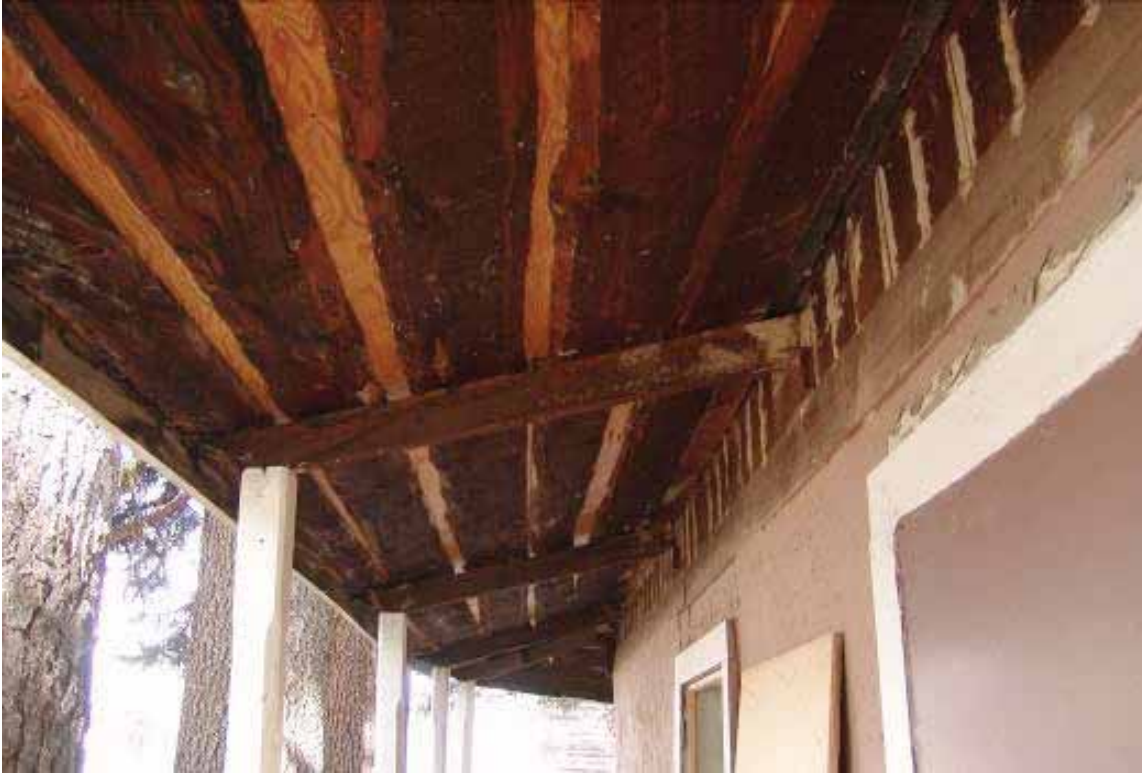
The north, east, and west elevations of the Hotel are flanked by a shed porch roof. The roof is framed with rough sawn 2x4 rafters spanning about 3 feet from the exterior of the building to 3 inch by 3 inch chamfered posts which are spaced roughly at 6 feet (Photo 21). The porch roof is sheathed with rough sawn 1x decking, milled similarly to the decking on the main building, and it is overlain with plywood.

Photo 21: Underside of the porch roof framing

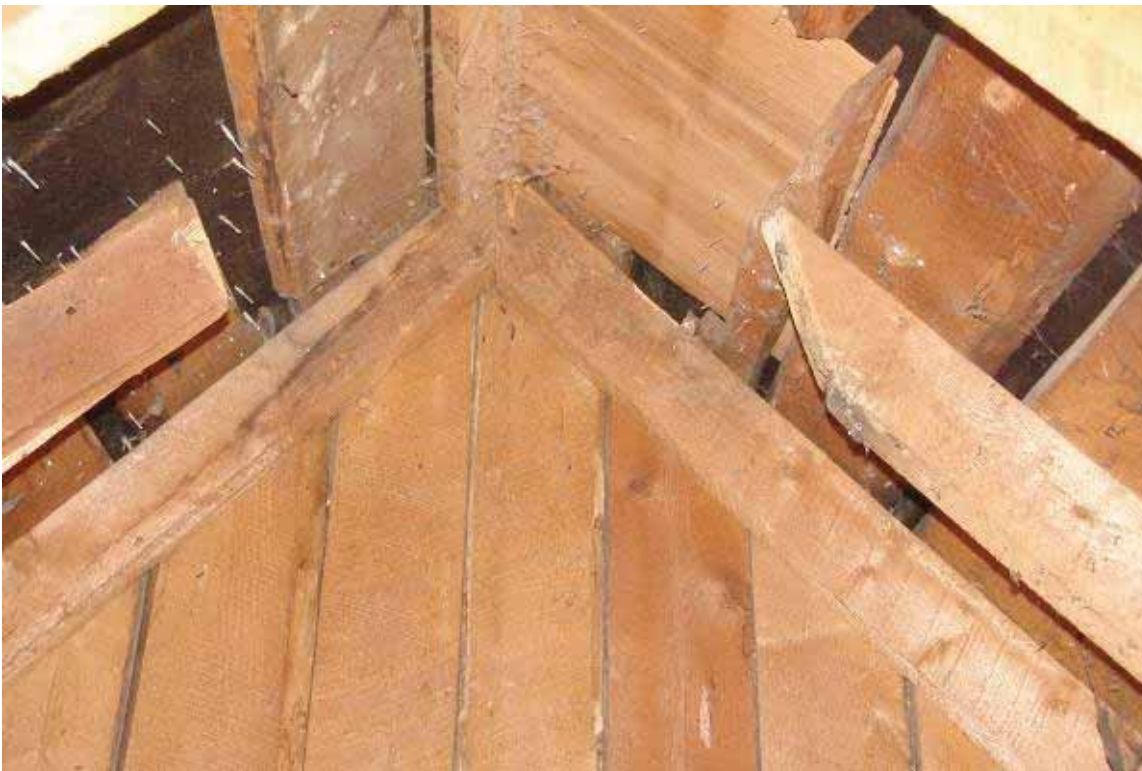
The framing over the main portion of the Hotel is largely in fair physical condition but there are some defects that require repair. In the northwest corner of the main building, one of the roof rafters is split and the framing is cut at a former flue location (Photo 22). The chimney interrupts the two collar ties closest to south wall of the main building. The framing in this area is also not sufficiently sized to support the weight of the chimney within code allowable stresses. In most places in the attic the roof framing was observed to be performing satisfactorily. Although the rafter, collar tie, cripple stud, and second floor joist assembly is not robust compared to today's standards, in most places in the attic the framing was observed to be performing satisfactorily and, pending confirmation from the building official, need not be strengthened comprehensively. The addition of plywood sheathing atop the horizontal skip sheathing as well as bolstering the rafter to second floor joist connection along the sidewalls will greatly enhance the roof framing's structural integrity.

Photo 22: Cut rafters at former roof penetration locations

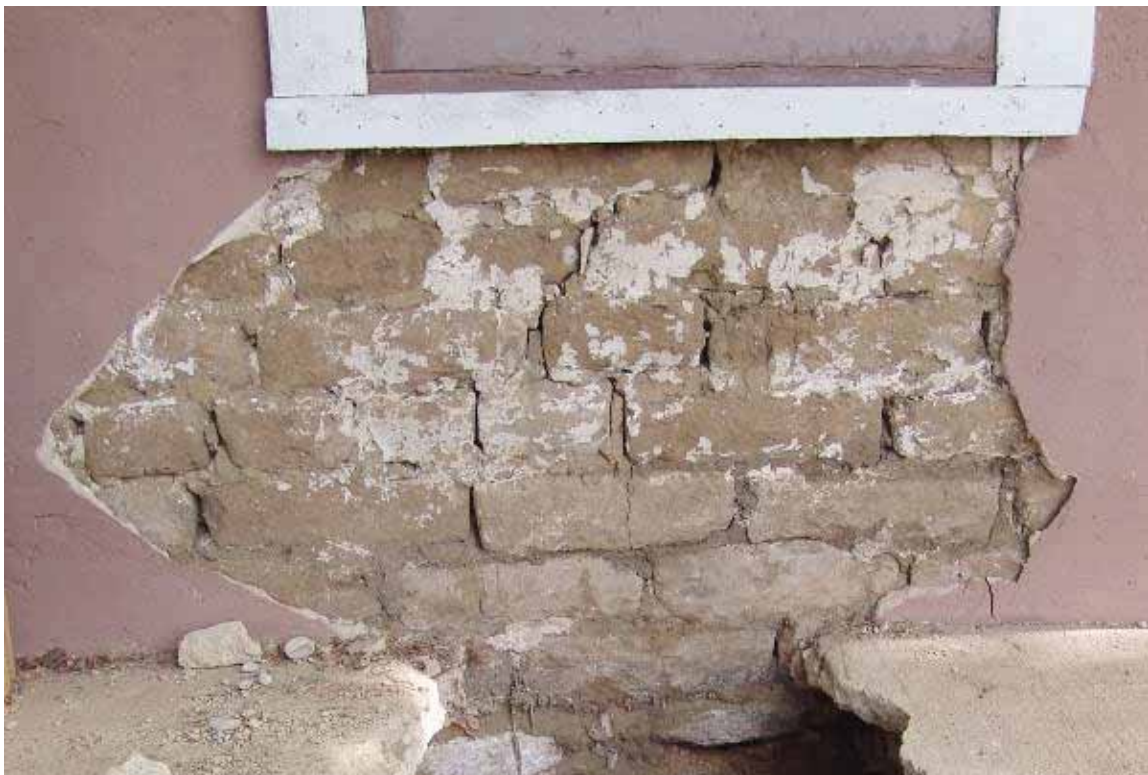
Photo 3.4-5. Adobe wall on north elevation

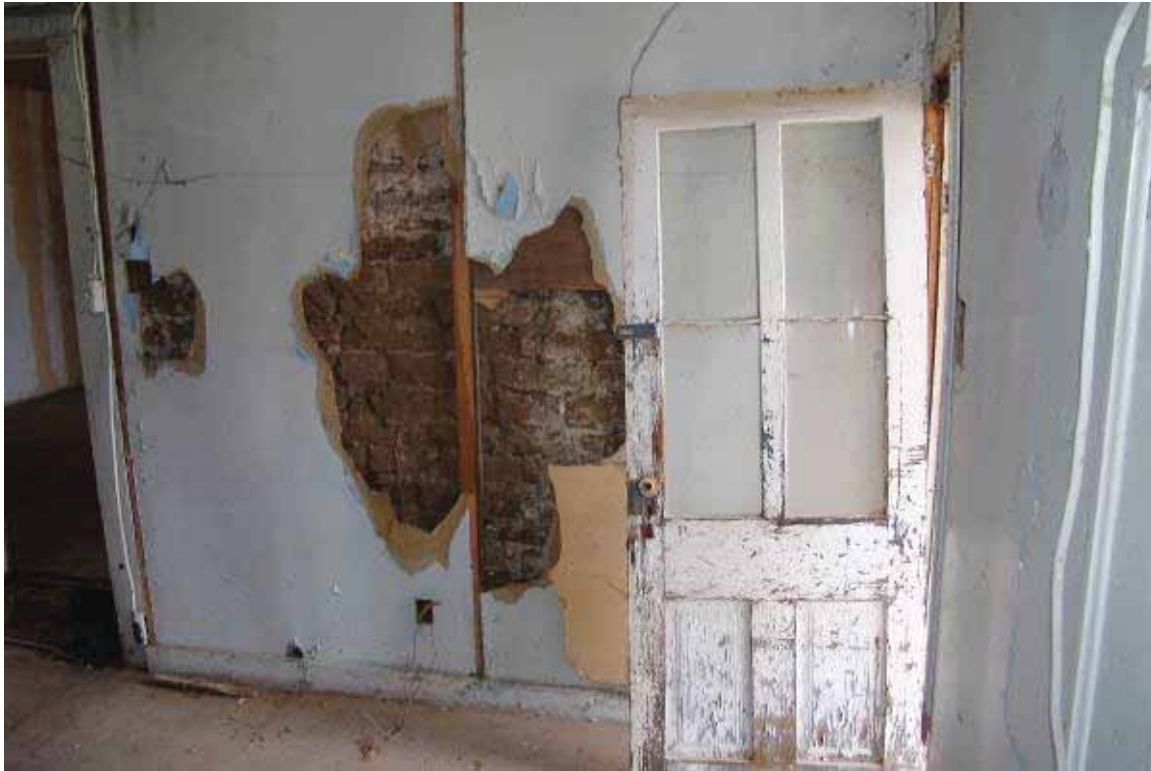
Photo 3.4-6: Adobe wall on south elevation of main building. Looking north inside Room 3

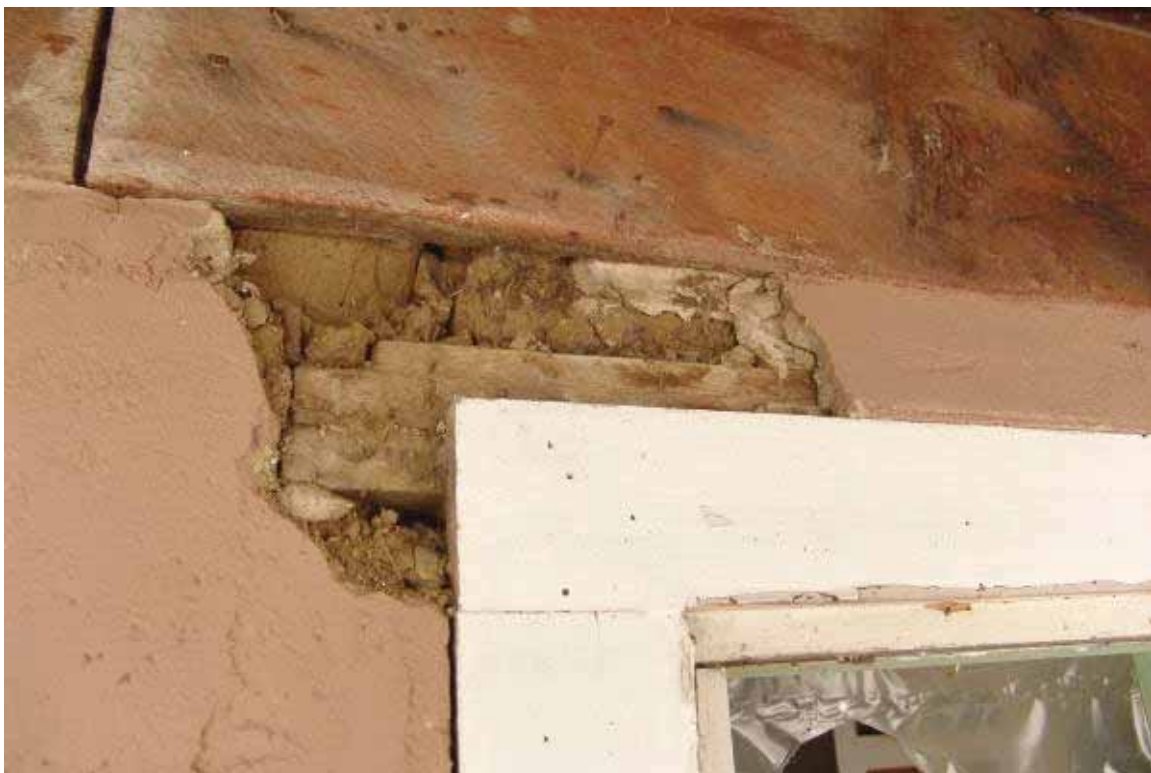
Photo 3.4-7: Flat wood lintel embedded in adobe assembly along east elevation

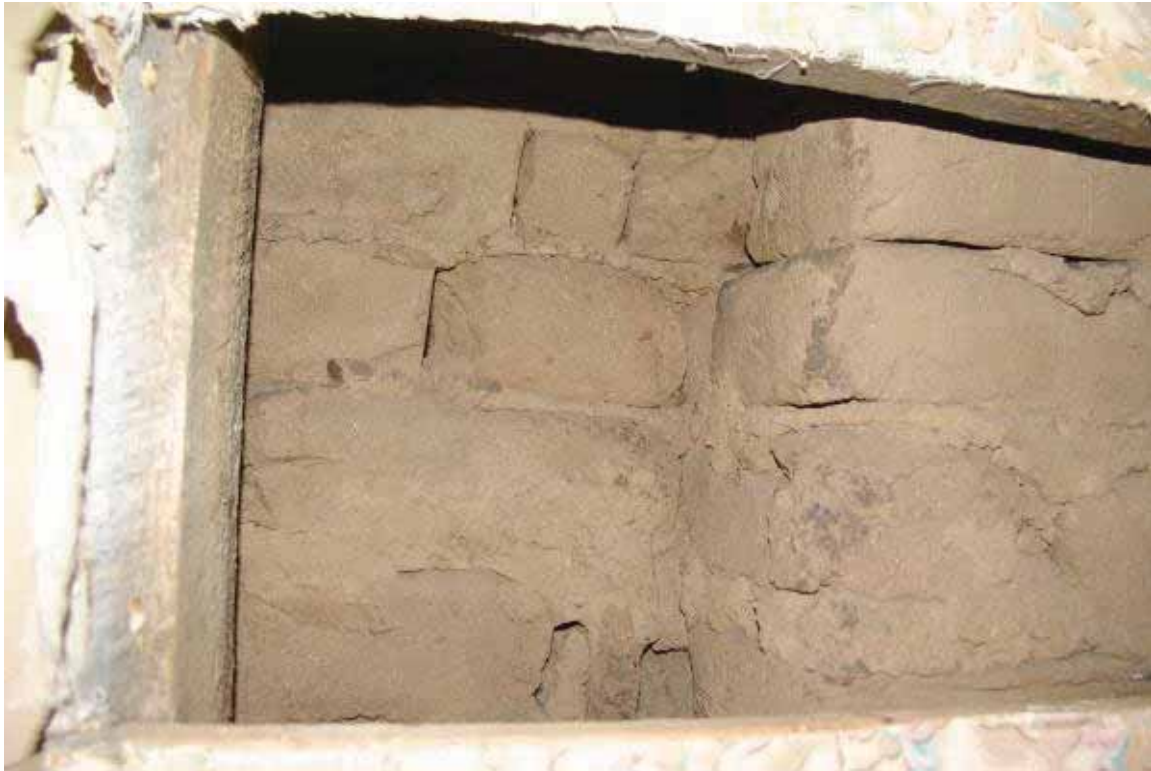
Photo 3.4-8: Adobe chimney behind furring wall on first floor inside Room 2

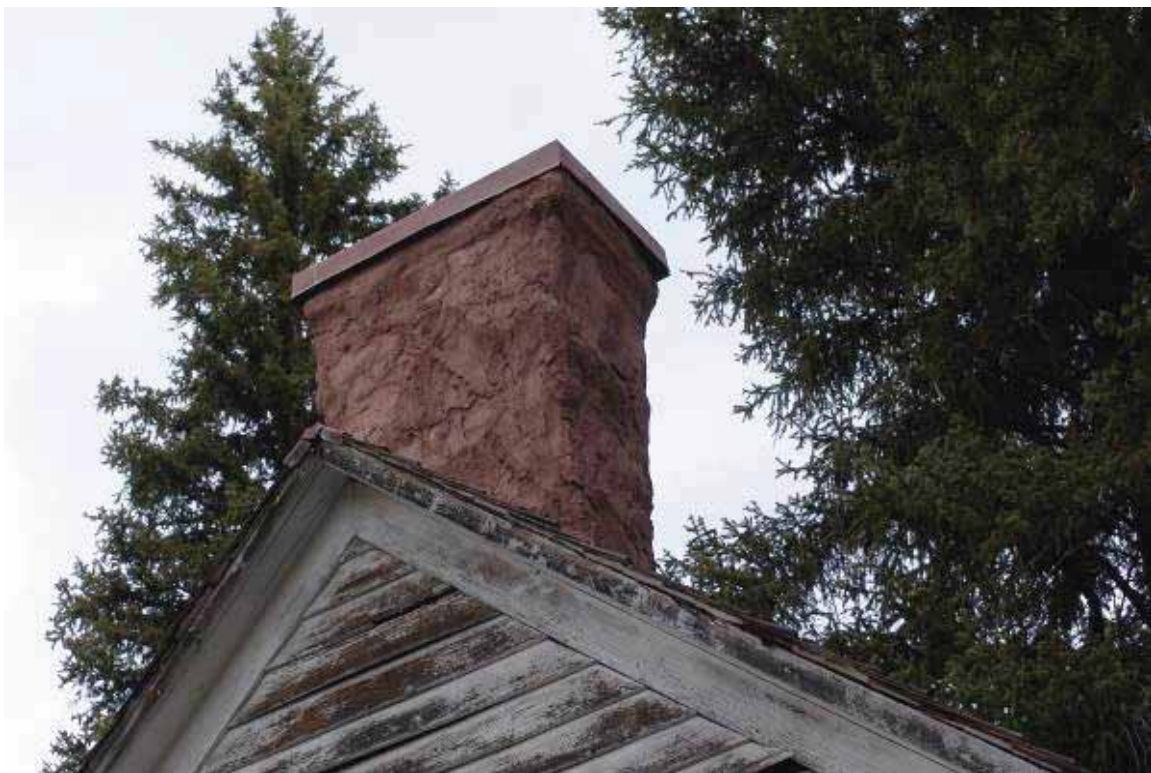
Photo 3.4-9: Adobe chimney above roof

The adobe chimney is bowed out at the top. The plaster looks loose at the base of the chimney. Metal cap flashing and base flashing are in good condition.

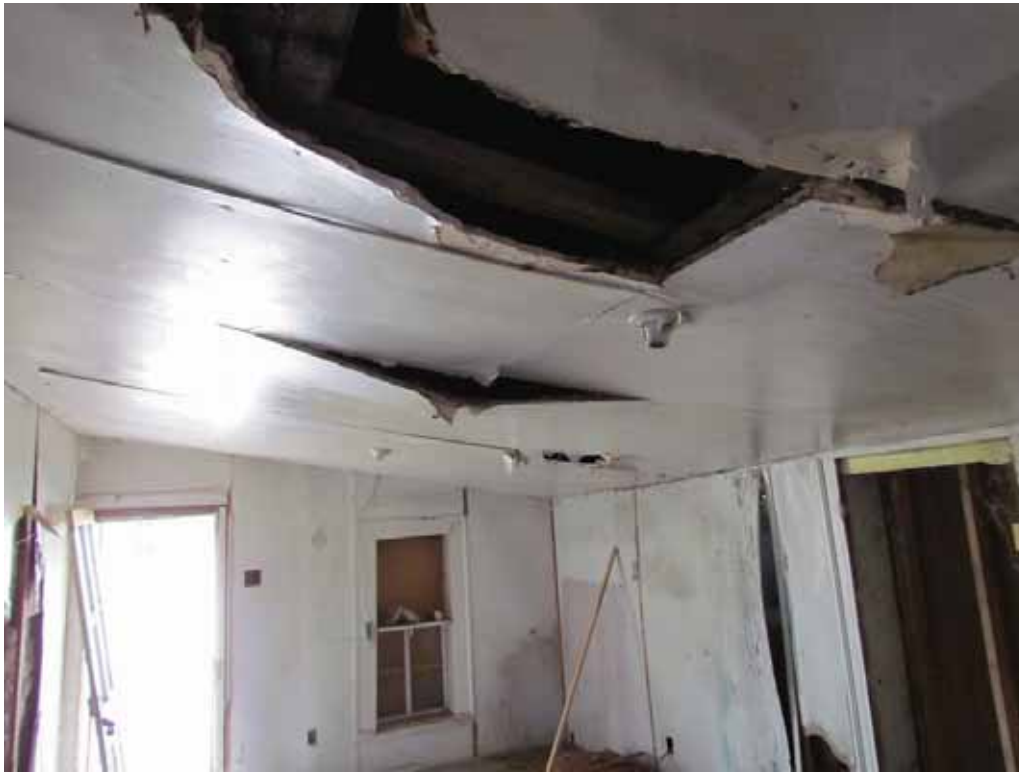
South Addition (Photos 3.5-3, 3.5-4)

The south addition roof is partially collapsed and is in very poor condition. The roof decking is partially collapsed, roofing partially failed, and trim very deteriorated.

Photo 3.5-3 showing collapsing roof/ceiling in south addition. Room 3, interior.

- Replace south gable trim. (Serious)
- Replace south gable siding. (Serious)
- Replace/splice 5 split exposed rafters, west side, below porch roof. (Serious)
- Replace all trim, all dormers. (Serious)
- Replace siding, south-facing dormer walls, west side. (Serious)
- Replace roofing, southern dormer, west side. (Serious)
- Flash dormers to main roof. Flash all dormers walls to dormer roofs. (Serious)
- Replace loose plaster on chimney. (Serious)
- Rebuild south addition roof. Some framing may be salvageable. (Critical)
- Replace entire porch roof structure. Some framing members may be salvageable. (Critical)

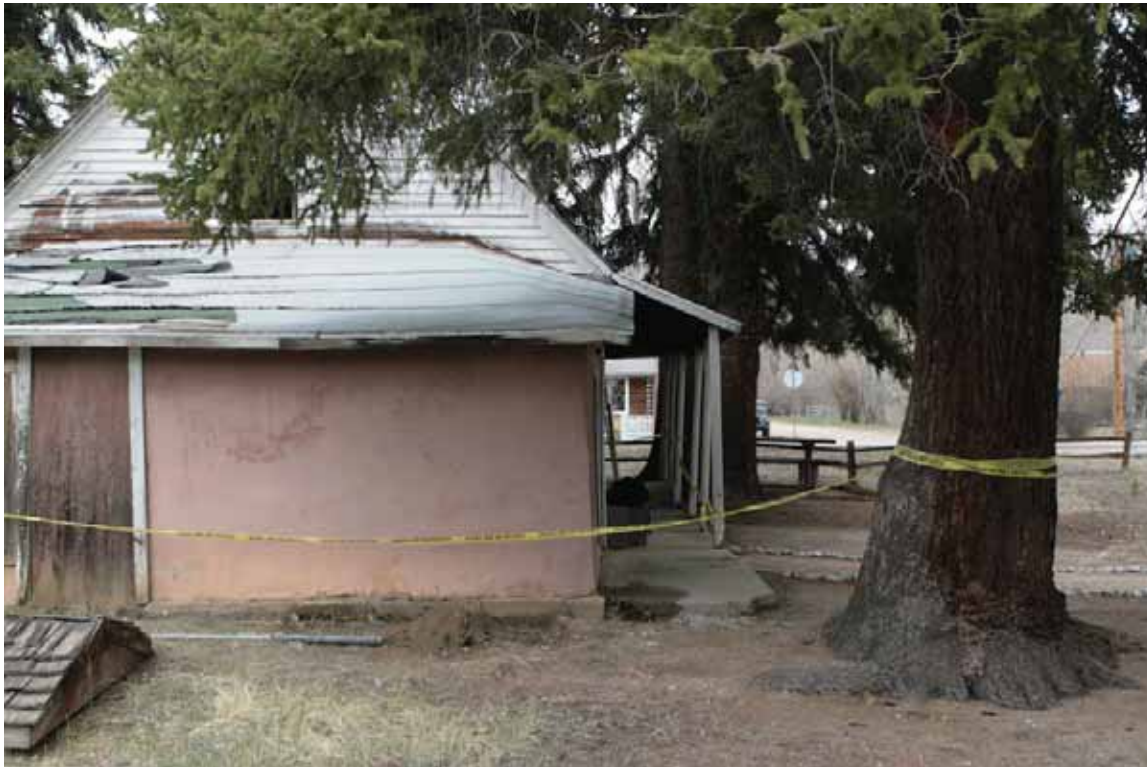
Photo 3.5-4 showing collapsing roof in south addition.

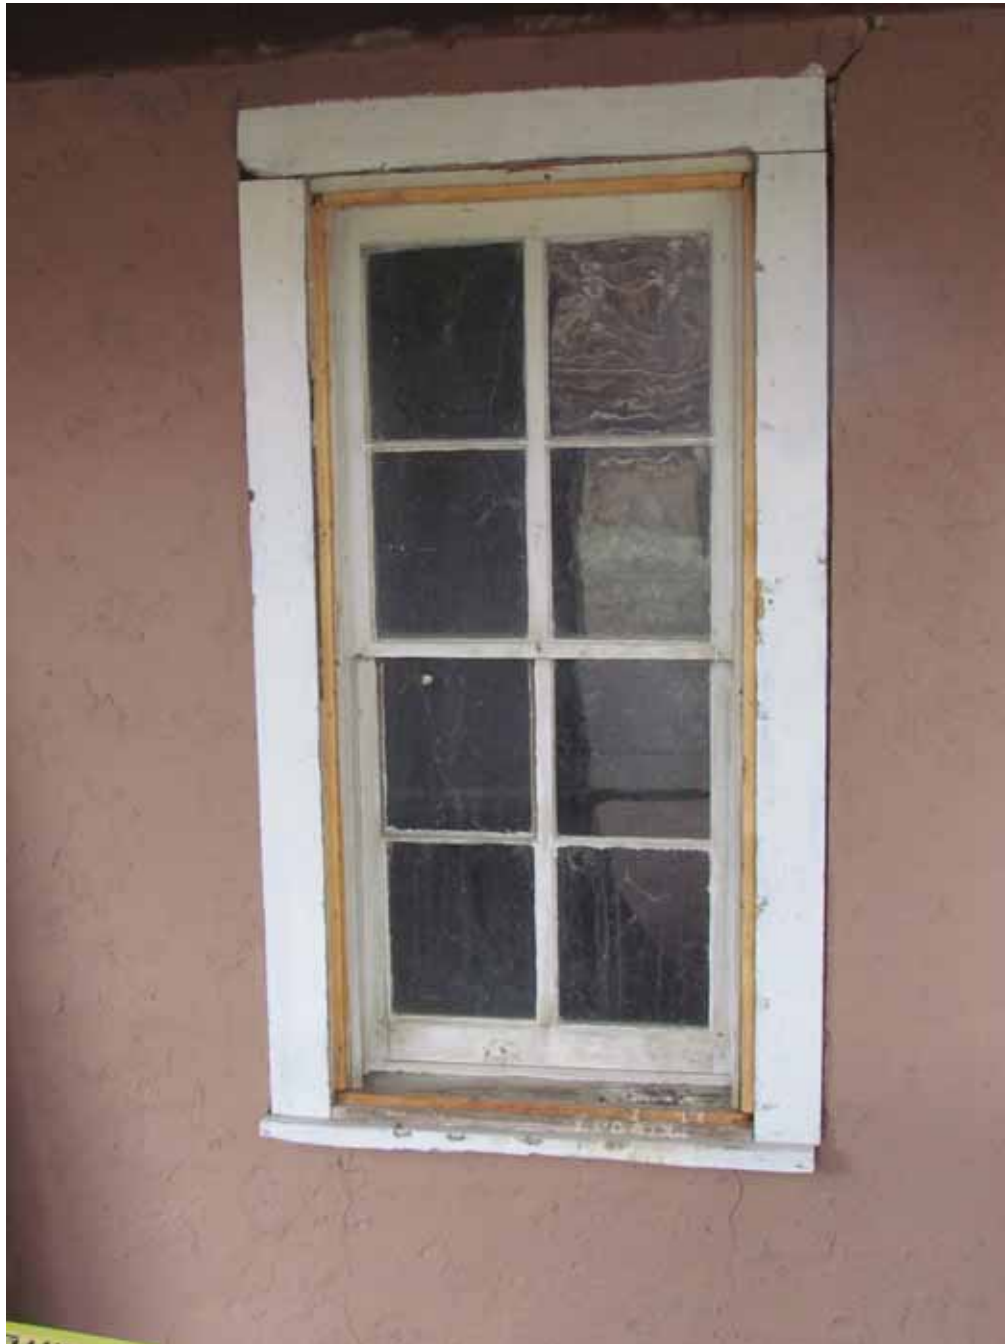
First floor, east elevation (Photo 3.6-1)

Photo 3.6-1. First floor, east elevation, exterior of window

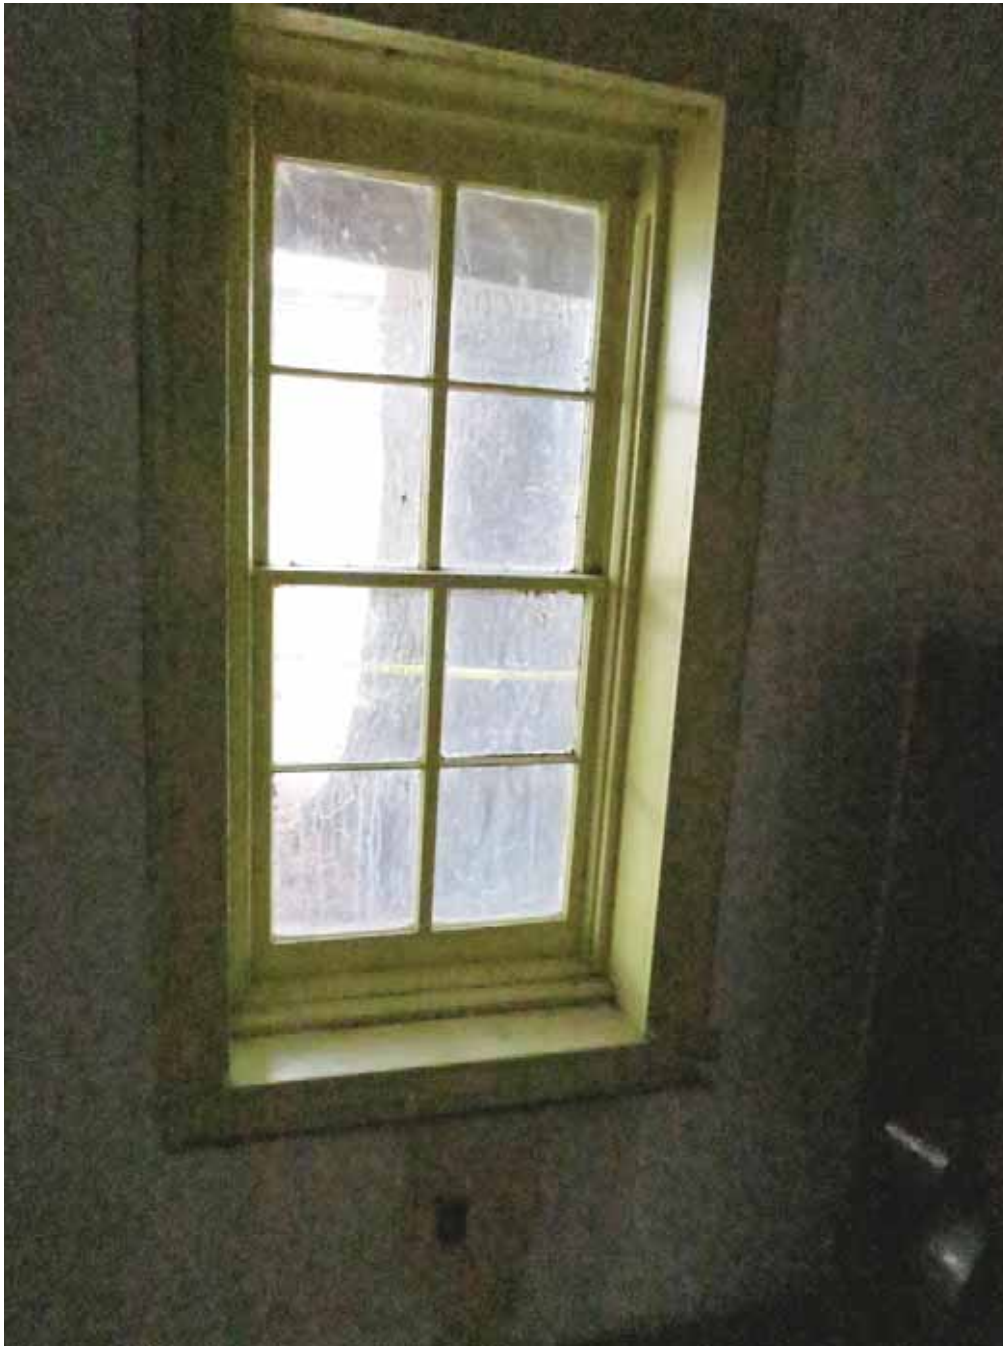
North end, at Room 1: wood sash, double hung divided light historic window with simple exterior 1x4 wood trim painted white. Interior: jambs have been extended in by 4" to accommodate furred-out walls. Non-original simple crown and jamb molding. Sill trim has been removed, was 4" tall. No window hardware. (Photo 3.6-2)

Photo 3.6-2. First floor, east side, interior

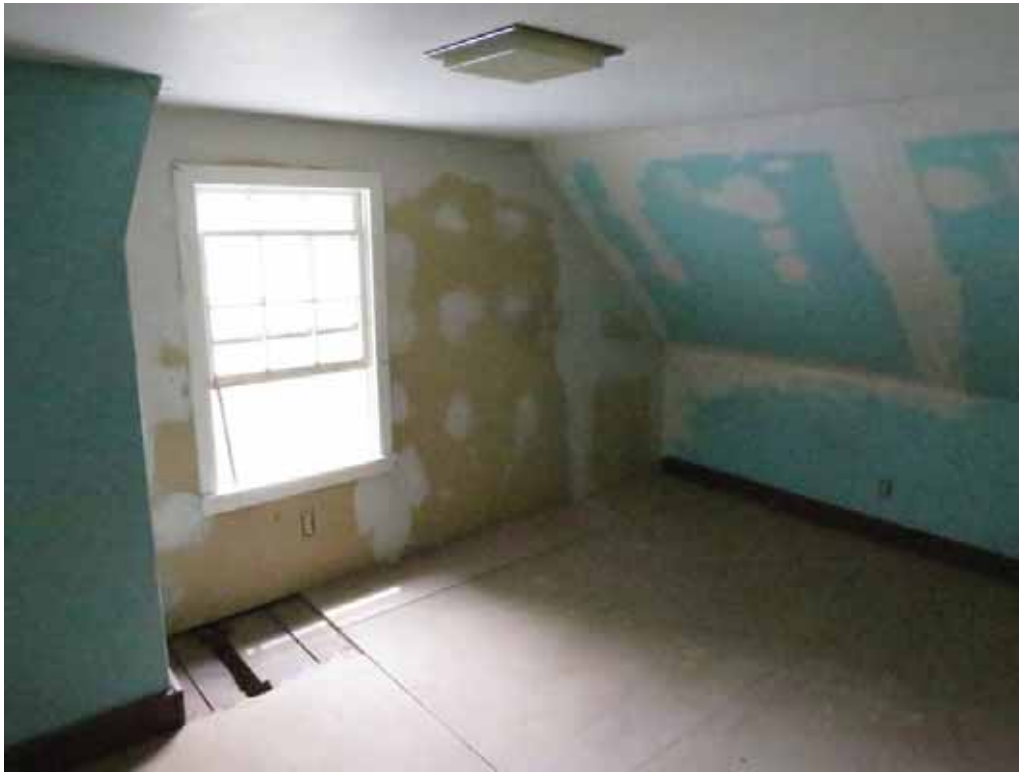
Wood sash $\frac{3}{4}$ divided light double hung, newer window. No hardware. In the north bedroom, the window sill is just above floor level. Simple 1x4 wood trim. (Photo 3.6-3)

Photo 3.6-3: South bedroom window

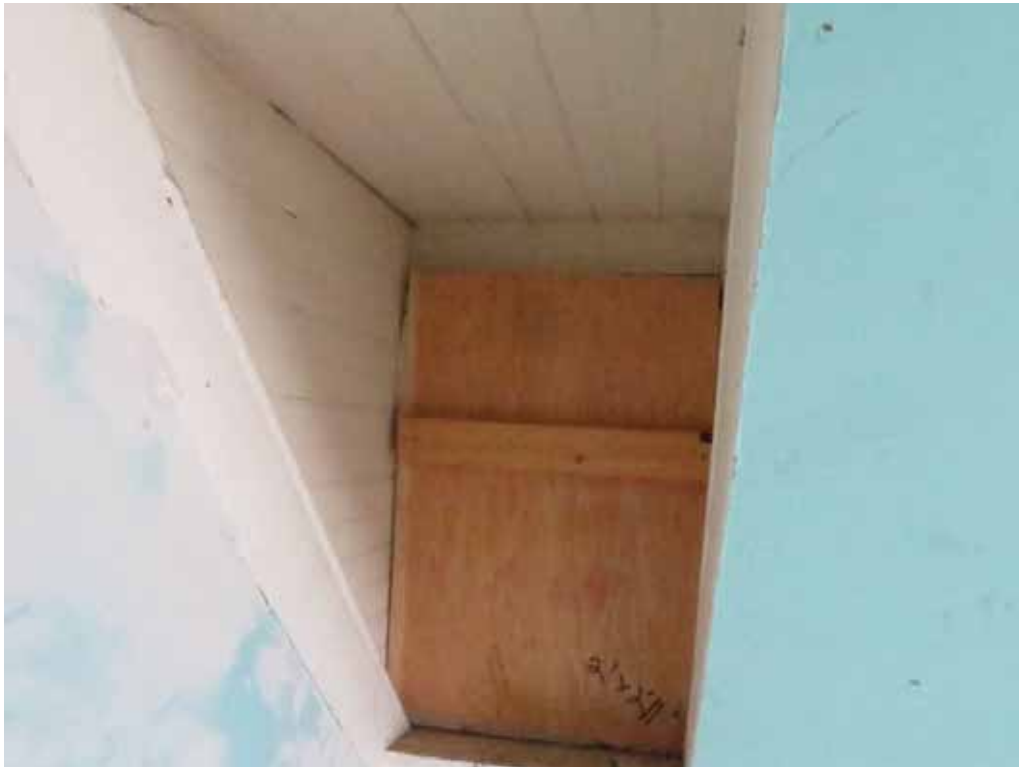
Photo 3.6-4: Dormer in South Bedroom

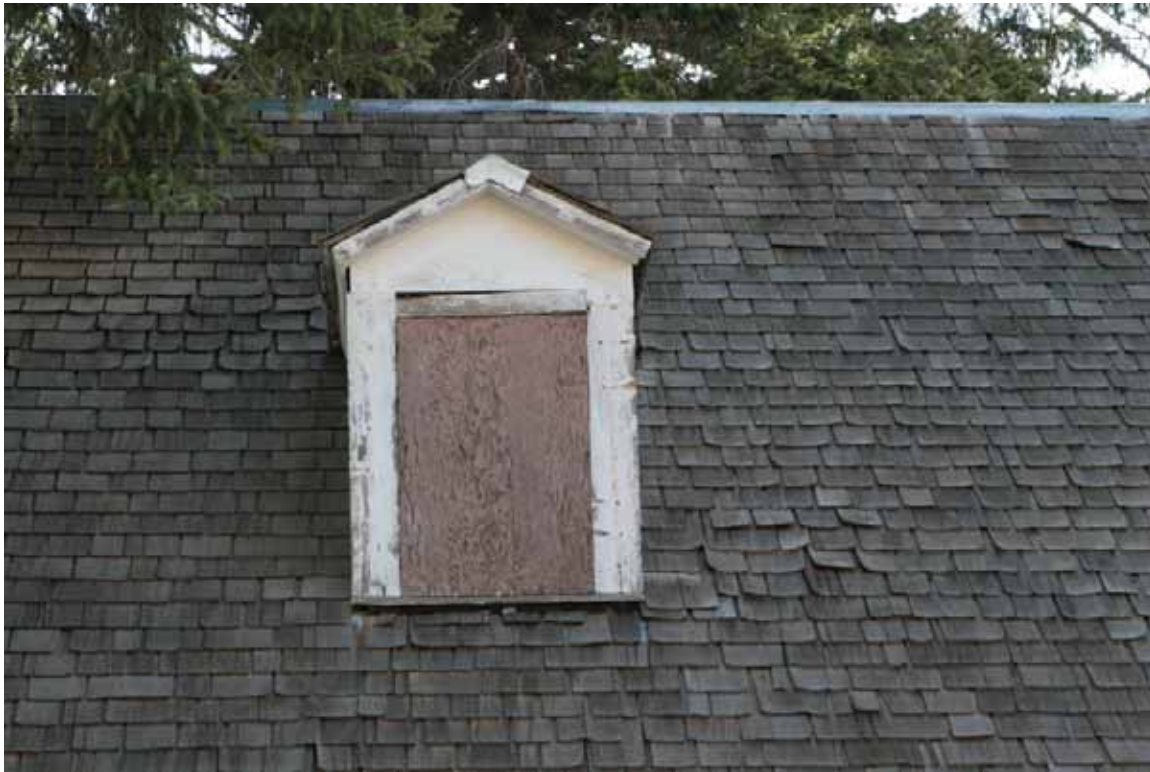
Photo 3.6-5: East side dormer
