CLARION HOTEL
TWIN LAKES, CO
HISTORIC STRUCTURE ASSESSMENT

PREPARED FOR:
FRIENDS OF TWIN LAKES
SHF 14-HA-008
FEBRUARY 5, 2015
DELIVERABLE #5

SHF 14-HA-008
FEBRUARY 5, 2015
5LK.41

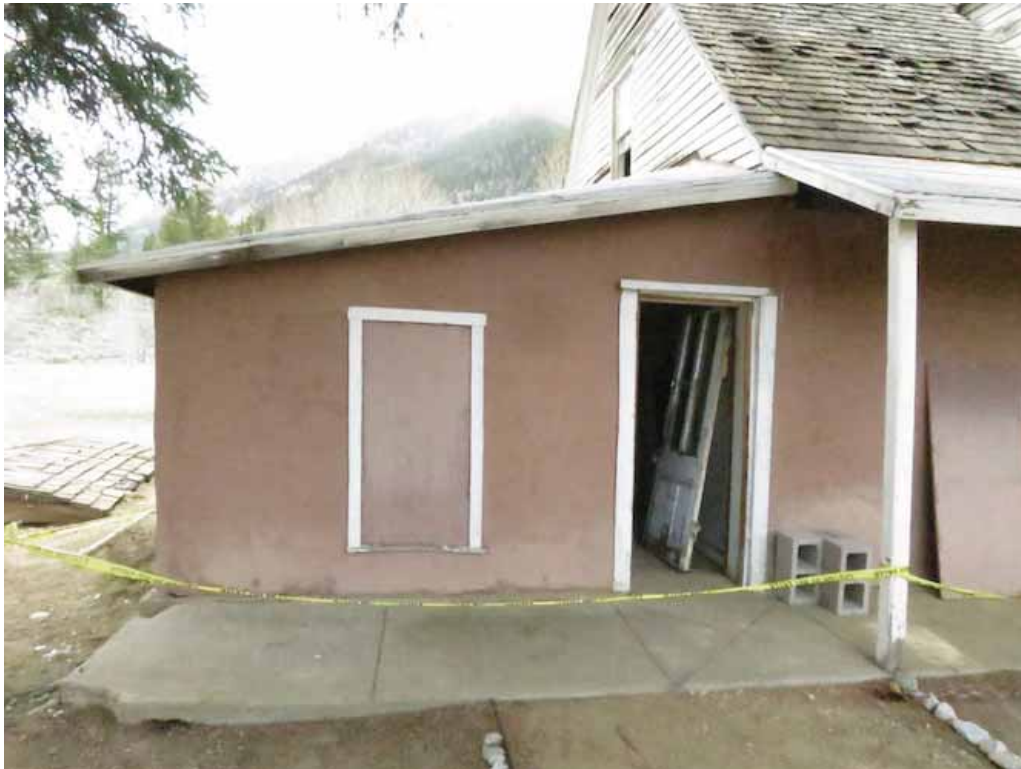
East exterior door into south lean-to addition (Room 3): wood door with four-light upper glass panel, and two lower wood panels. (Photo 3.6-6) The door has been removed and stored inside the room. The door has latching hardware of an older appearance. Porcelain door knobs have been removed and stored inside Room 3.

Photo 3.6-6: East side door into Room 3

If visitors are to be allowed into the building, exterior doors should be restored to be operational with working hardware. Doors should be cleaned, scraped and painted, with water-damaged portions spliced with new material. Remove north door frame and securely reattach to adobe substrate.

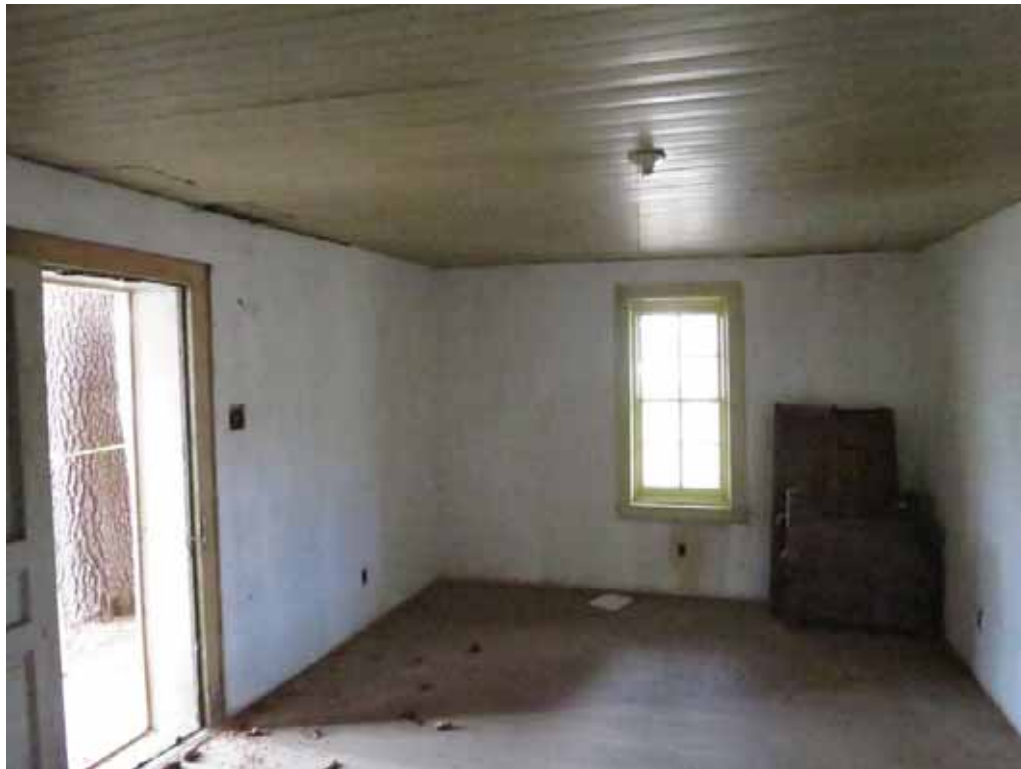
Room 1 is the northernmost room, roughly rectangular in plan, with an exterior door and one window to the north and one window on the east side. (Photo 3.7-1)

Photo 3.7-1. Room 1, looking east.

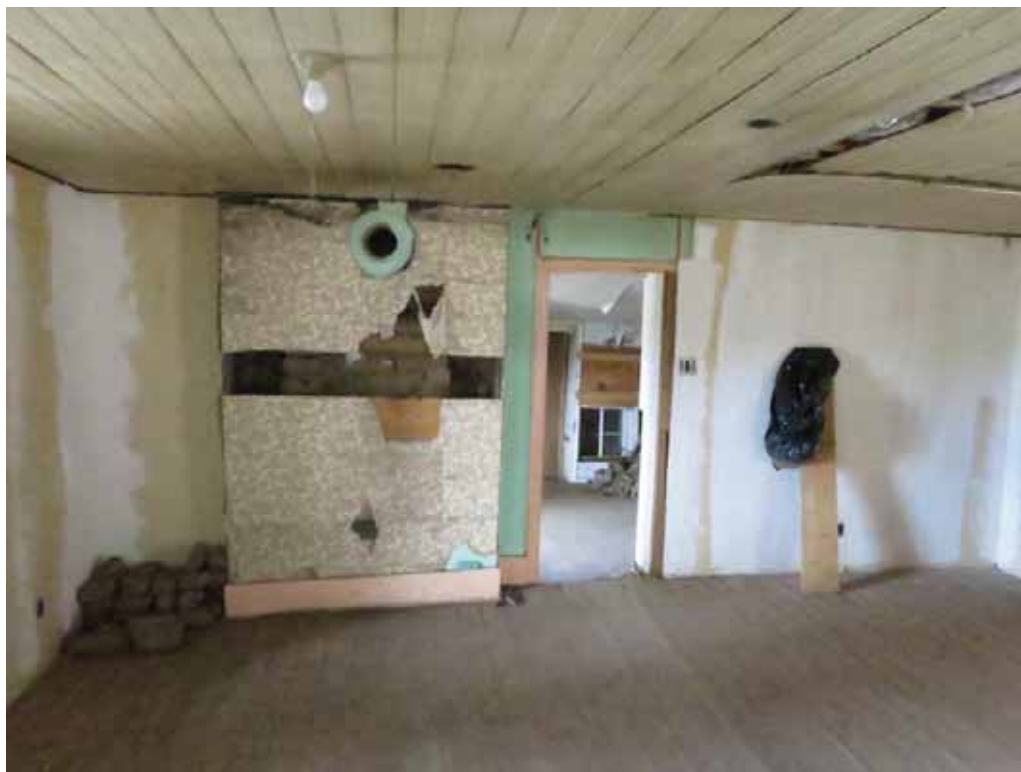
Room 2 is the center room. It is roughly rectangular in plan with two exterior doors and two windows. (Photo 3.7-2)

Photo 3.7-2. Room 2, looking south.

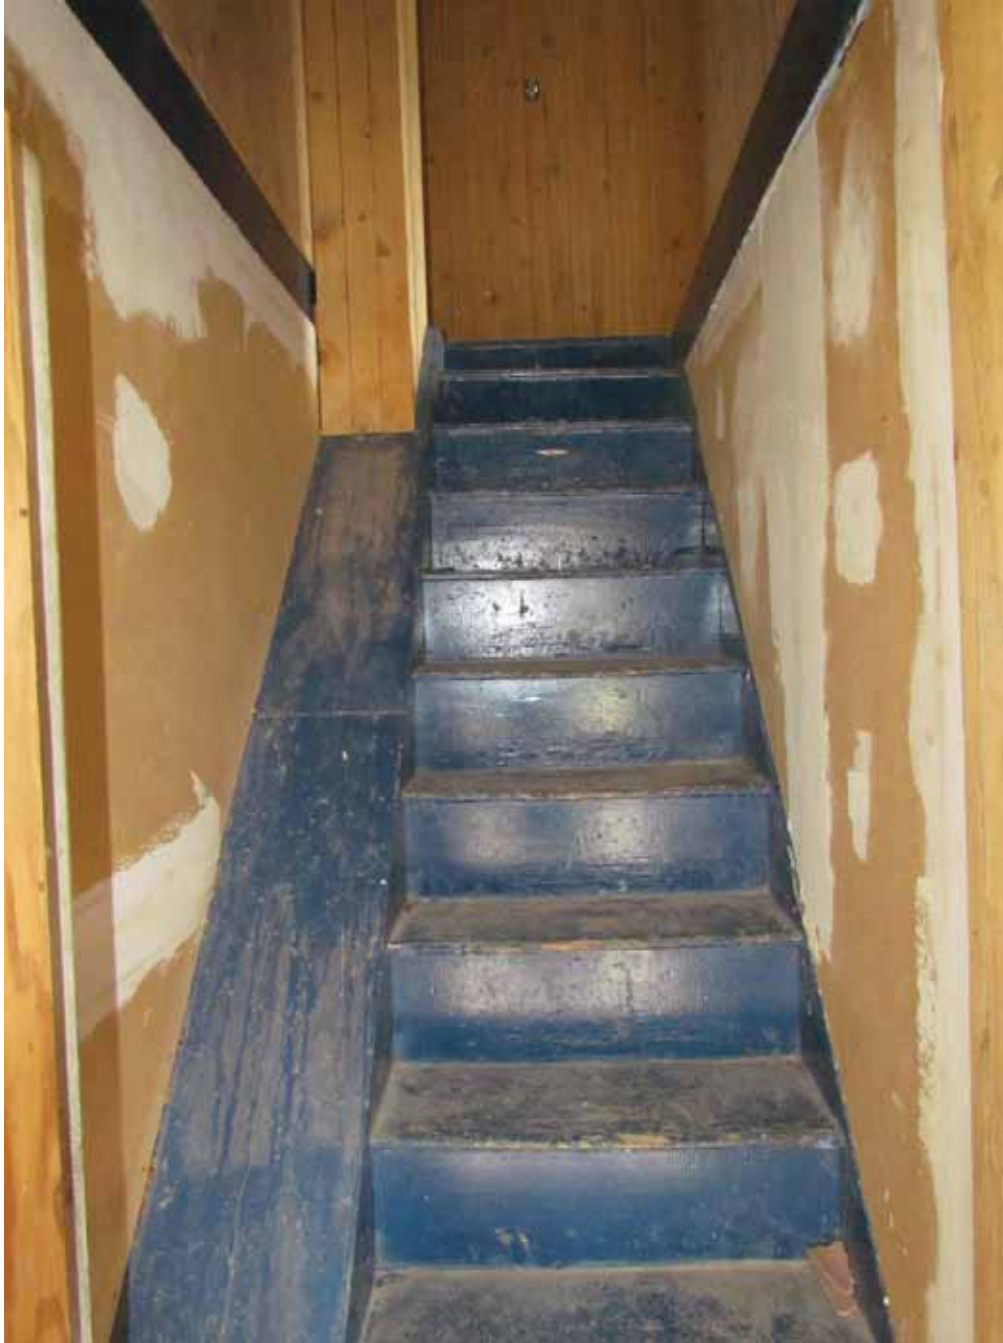
The Furnace Closet is under the stair, in the northwest corner of Room 2. It opens to Room 2. The stairwell and closet were widened to accommodate a furnace. The furnace, now non-functioning, still exists. Its flue runs up on a slope parallel to, and north of, the stairs. (Photo 3.7-3) Inside the closet, the undersides of the stair risers are covered with wallpaper and newspaper remnants. The newspaper remnants are in German. The closet floor is ½" x 6" unfinished boards over 1" boards.

The Stair (Photo 3.7-3) has a non-original opening to Room 2.

Photo 3.7-3. Looking up stairs.

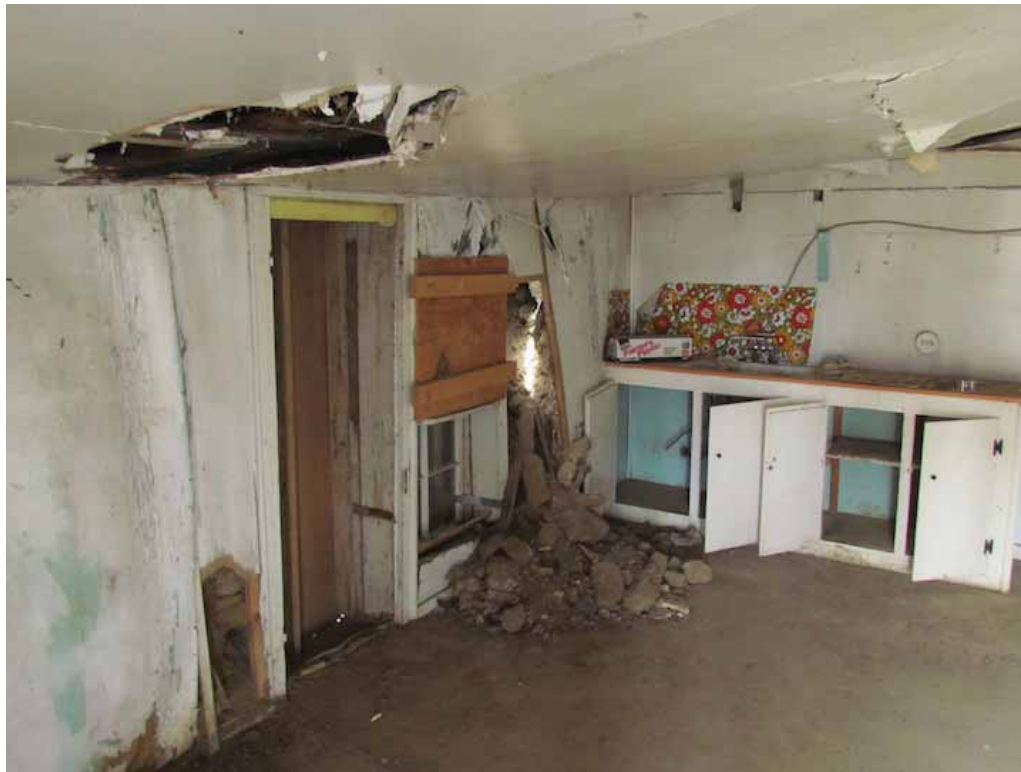
Room 3 (Kitchen) (Photo 3.7-4) is within the south lean-to addition. The room's shape is a very distorted rectangle, the distortion being due to a combination of structural displacement and poor construction techniques. The floor is 5" below Room 2. The floor has a pronounced slope to the south.

Photo 3.7-4. Room 3 looking southwest.

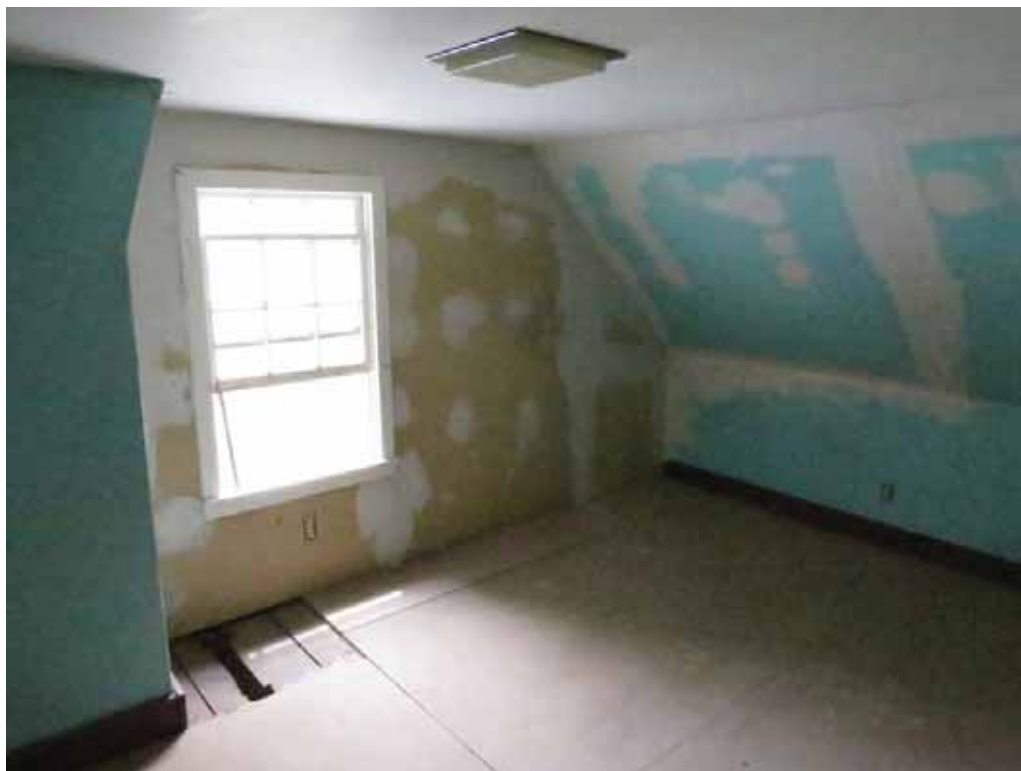
Second floor condition: Good. There is evidence of water damage inside some of the dormers, but it does not appear to be recent.

Photo 3.7-5. South bedroom looking southwest

Second floor recommendations: No work is recommended on the second floor, other than window rehabilitation (see Section 3.6). The second floor has been extensively remodeled, including removal of four of the eight original dormers that provided natural light to the original guest rooms. The second floor original layout could be reconstructed, with reconstructed dormers. However, in order to comply with the Secretary of the Interior's Standards, an ultimate treatment of reconstruction (rather than preservation or rehabilitation) would require additional research. A reconstruction treatment would require that the entire building be returned to its documented condition during a specific time period. At present, no known historic photographs depict the Clarion with all eight dormers *and* in its current floor plan configuration. Various wings, no longer extant on the west and south sides, are visible in the historic photographs that show eight dormers. (See historic photographs in Section 2.1). While there is some interest in reconstructing the missing dormers, there is presently no interest in reconstructing the missing west and south wings.

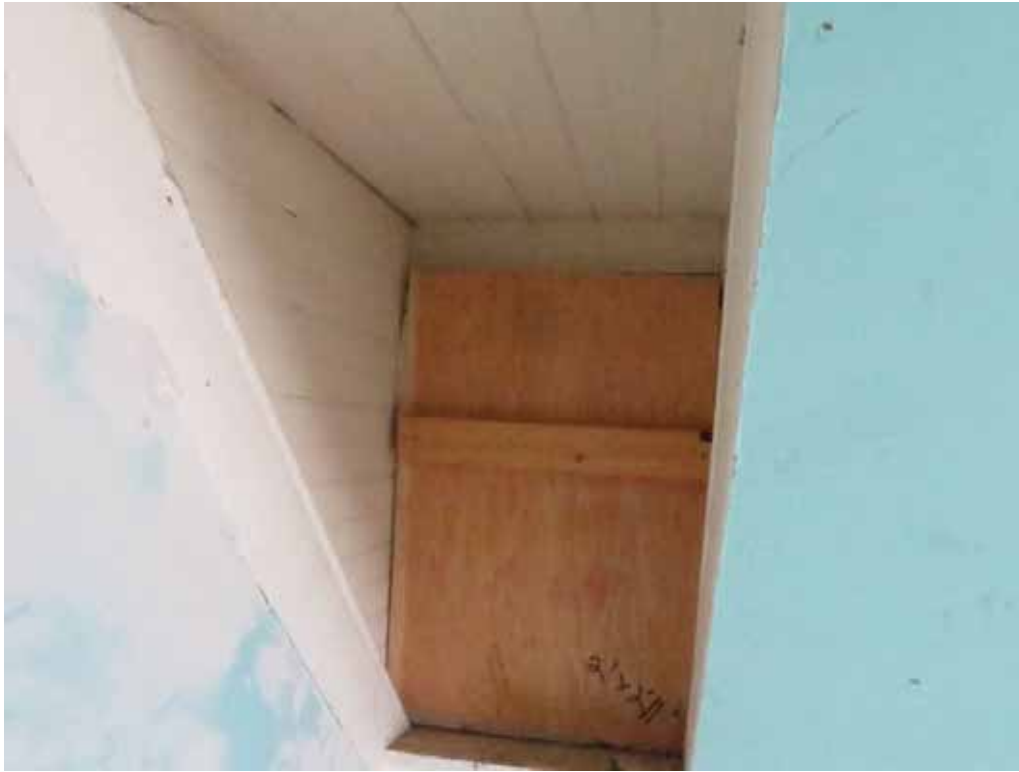
Photo 3.7-6. South bedroom dormer
